Kingfisher Pond - Northstowe Hydrogeological Assessment

Phase III Report

FWM8714-RT003-R01-00

May 2021

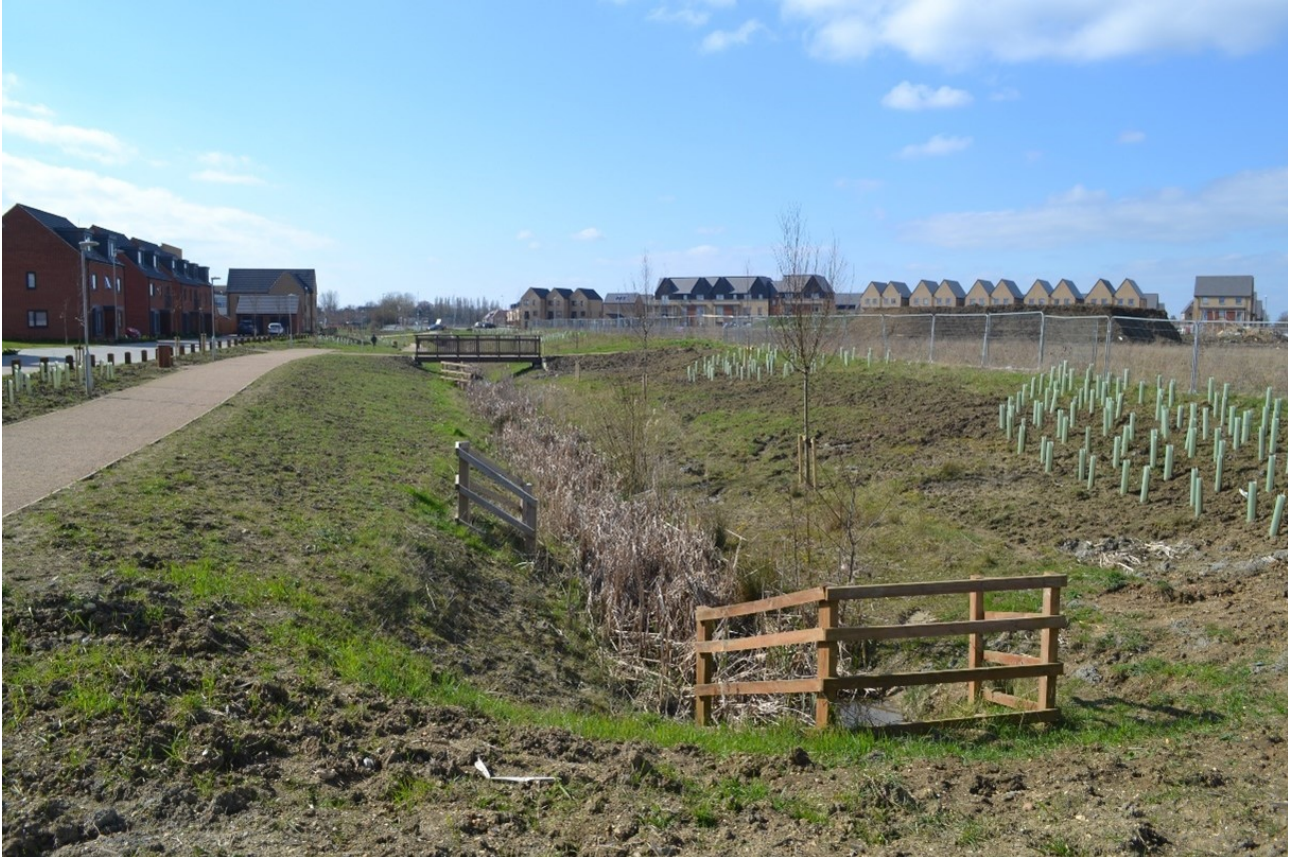
WSP (2014) state that the typical water level in the RTD is 0.5 to 2 m below ground level. Photograph 4.1 (HR Wallingford, 2021) shows a typical section of one of the greenways. In this photo it is apparent that there are long sections of the greenways which are greater than 0.5 m deep. It is unclear if the design principle of maintain the greenways above the water table has been met. There is a possibility that these greenways are located below the natural water table in the RTD in some sections.

Photograph 4.1: Greenways on the site of Northstowe

The design of Northstowe includes the installation of ditches (referred to as greenways) to prevent flooding. These greenways provide a preferential flow pathway allowing water to travel attenuation ponds. A key design principle was to maintain the greenways above the water table otherwise the greenways would convey groundwater from the aquifer towards the attenuation ponds (Wardell Armstrong, 2017). Given the shallow groundwater table, careful construction of the greenways would be required to prevent permanent lowering of the water levels in the RTD.
