TAIC REPORT NUMBER 41

JAPANESE BALLOONS AND ATTACHED DEVICES

TECHNICAL AIR INTELLIGENCE CENTER
NAVAL AIR STATION
ANACOSTIA, D. C.

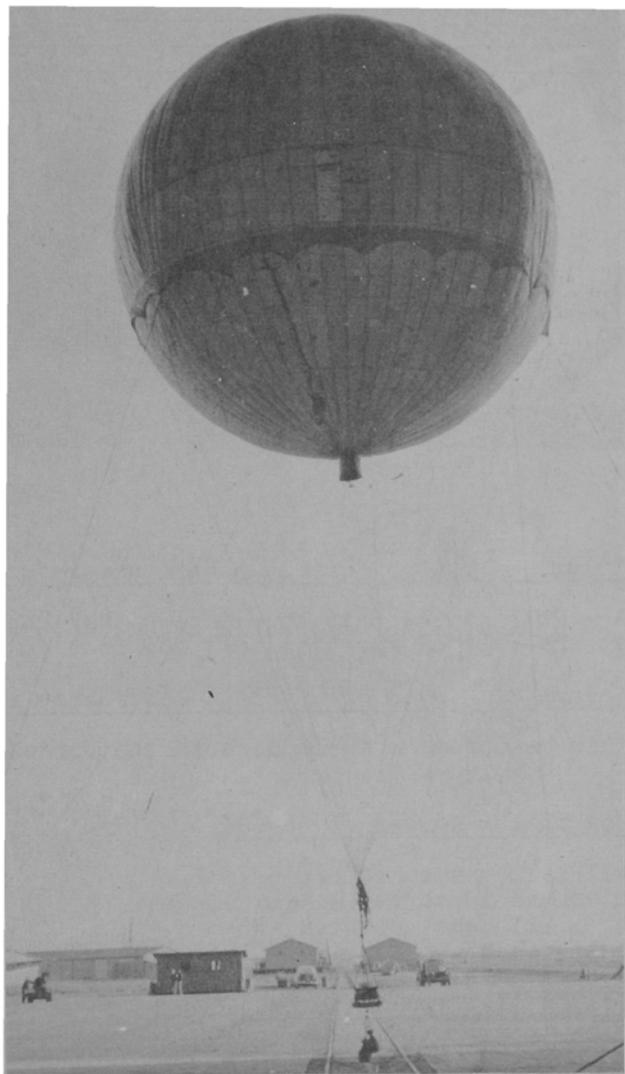
Fig. 1

Column 1. (fig. 1) Envelope

The number of plies has been found to be four or five of long fiber paper.

The number of gores is determined by counting the strips on either side of the center line of the balloon. (Note in fig. 1 that the gores do not run continuously from top to bottom.)

6. The material of the envelope consists of 5 layers of thin long fiber paper cemented together with hydrocellulose, a parchmented form of cellulose. The long fiber paper gives high strength and the hydrocellulose gives gas impermeability. The degradation of the cellulose to hydrocellulose has been carried so far that 20% of the total weight of the balloon material is water soluble. The material increases 67% in weight when wet.

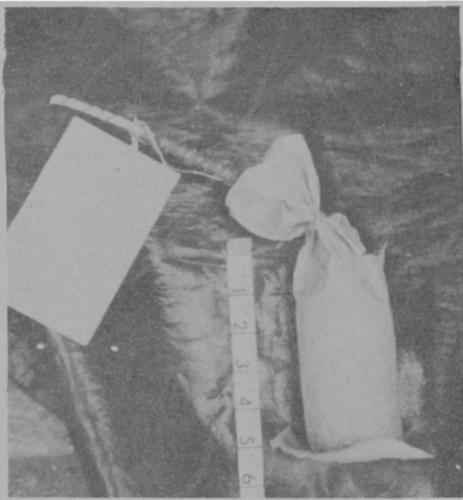
Column 7. Envelope destructor Fig. 2

The envelope destructor is a paper sack containing 250 grams (8.7 ounces) of magnesium flash powder and is cemented to the envelope above the cantenary band.

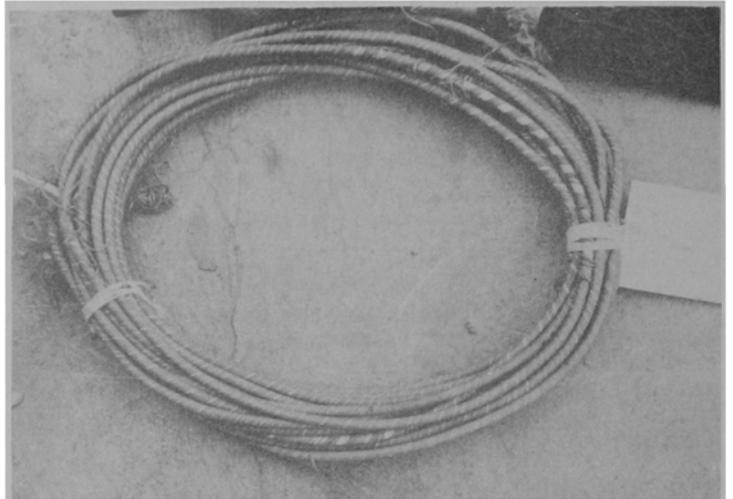
Column 8. Type of envelope destructor fuze. Fig. 3

A - This is the only type fuze so far found. It is a paper cord fuze that burns at the rate of approximately one foot in 66 seconds.

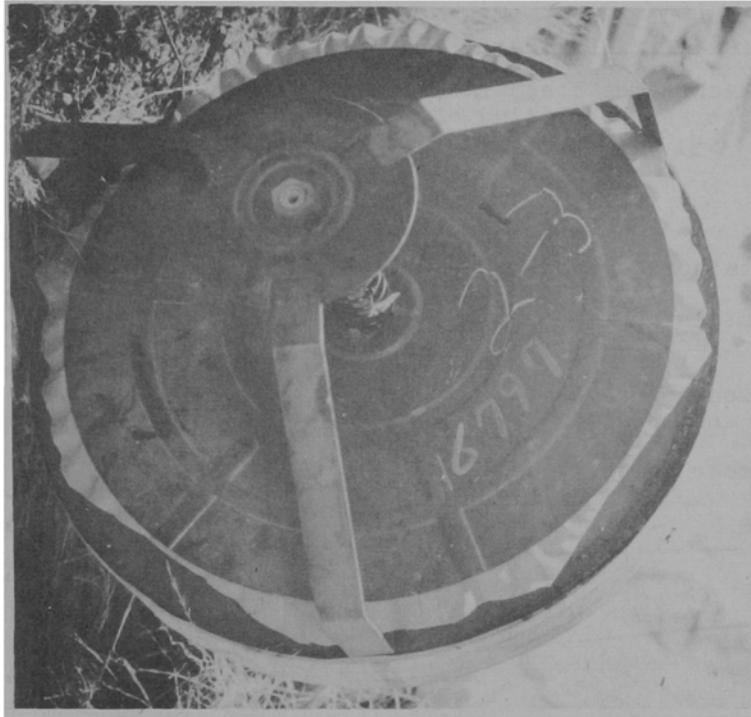
Fig. 5
Type A

Column 12. Fig. 5 and Fig. 6. Type of valve.

The valves reported are made from .041 inch thick metal with an outside diameter of 19.5 inches. The valve opening is 17 inches in diameter. There are two types.

- A - Fig. 5. This type has flat supports and a rather elaborate pressed pattern in the diaphragm.
- B - Fig. 6. Has pressed ribbed supports and simple circular pattern pressed into the diaphragm.

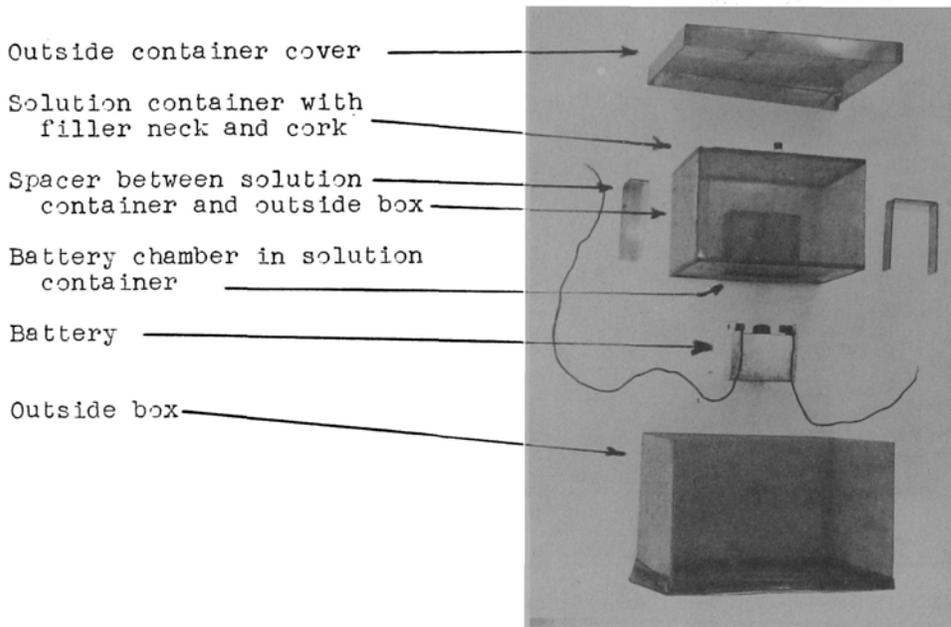
Fig. 9

Column 18. Fig. 9. Battery

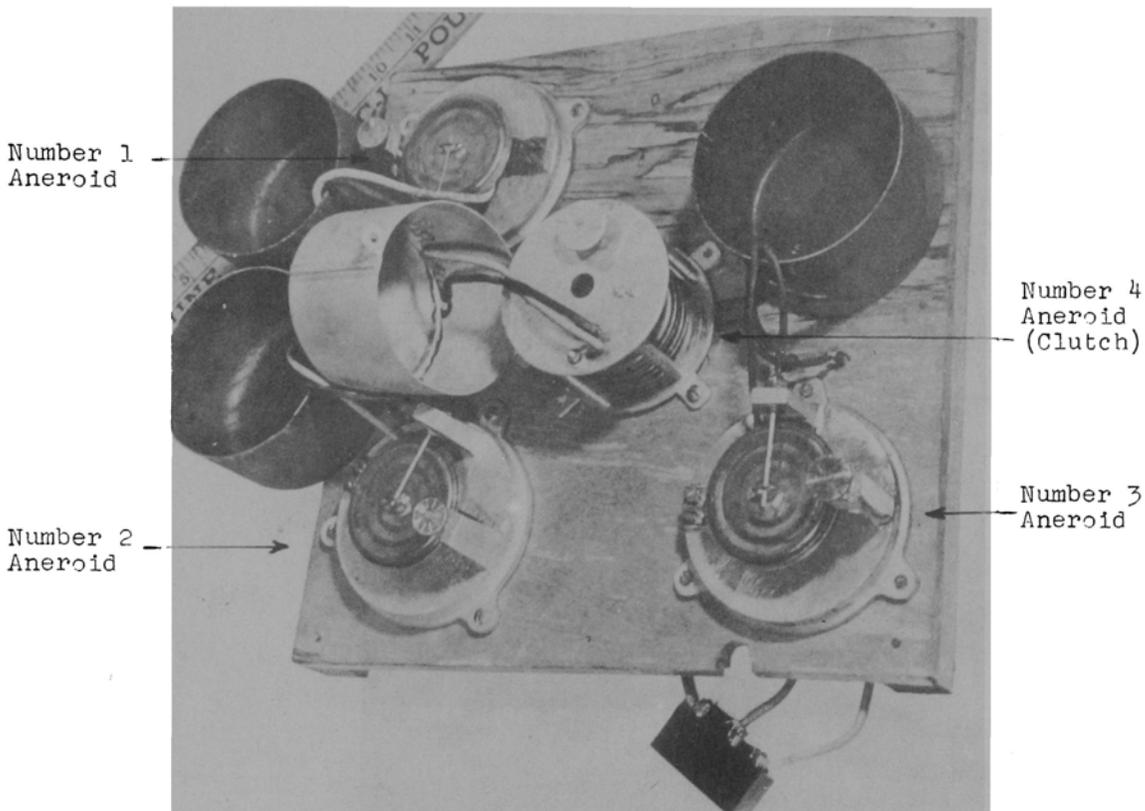
Column 22. Aneroid type. Fig. 12

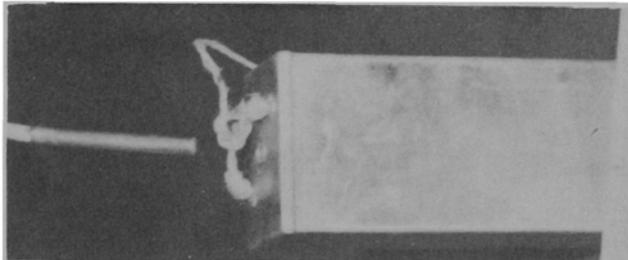
FIG. 13

The ballast gear destructor is a 2½ pound block of picric acid in a metal container. (Also shown in Fig. 13 is the detonator)

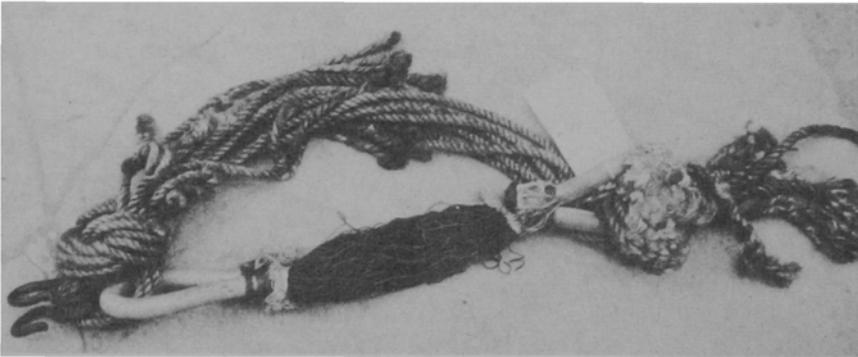
Fig. 7

Column 16. Rubber shock absorber. Fig 7.

Only one type has so far been found and this type is not found on all balloons. It is made up of 250 strands of $\frac{3}{64}$ inch rubber bands held in a woven cotton cover at the ends. It is 22 inches long with ten inches of rubber exposed. A load of 100 pounds will cause the sister rope to become taut.

20. These results indicate that the shock absorber would not be very efficient for a load in excess of 100 pounds and ineffective for a load exceeding 150 pounds. At 150 pounds the siezed eyes on the rubber begin to slip exposing a clean surface of the cotton covering. At 200 pounds the slippage is pronounced and failure would result after a short period due to the tendency of the rubber to creep out of the siezing. It seems probable that the shock absorber was intended for a load not exceeding 100 pounds and that it has never been used with a load exceeding 150 pounds.

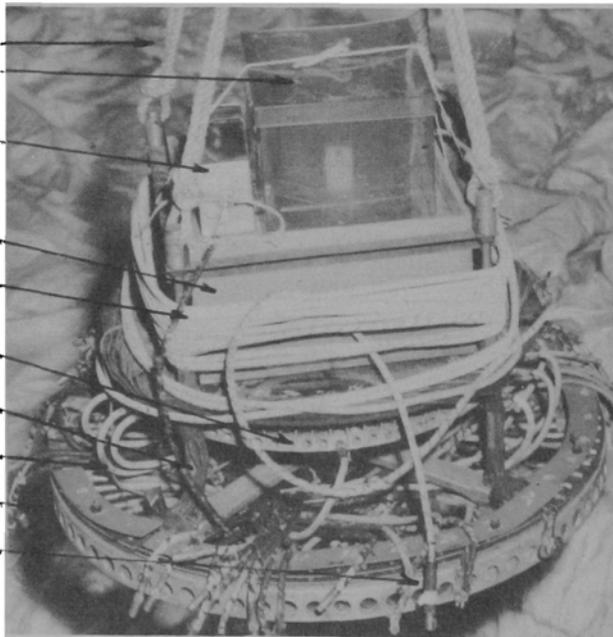
Column 17. Fig. 8. Ballast gear.

Fig. 8 represents the standard ballast gear and any deviation from this should be noted, such as the placing of the ballast gear demolition block under the aneroid housing, etc. This will be designated as A.

- Support lines
- Battery housing
- Ballast gear demolition block
- Aneroid housing
- Starting fuze
- Contact ring
- Blowout plug-ane-roid electrical leads
- Delay fuzes
- Ballast ring
- Starting fuze igniter

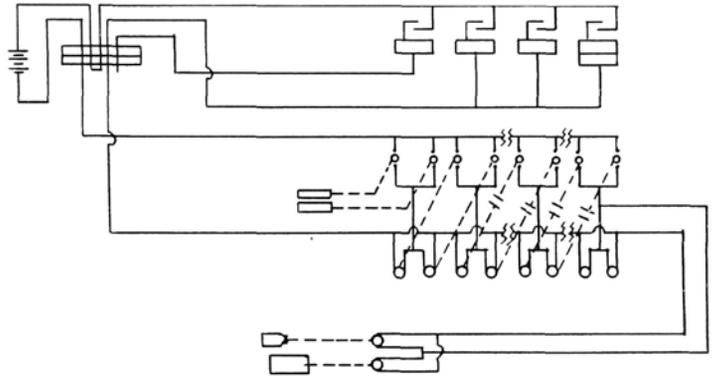
A - Wiring diagram
Figure 14.

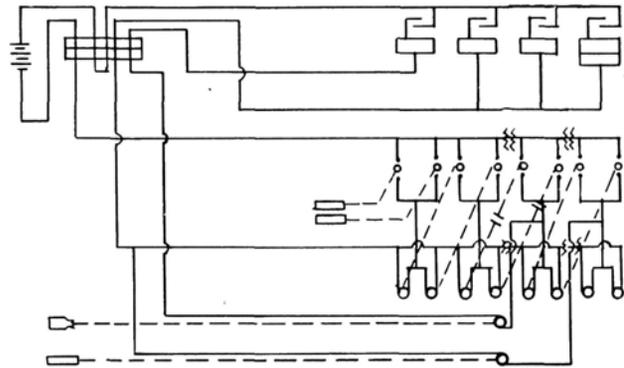
B - Wiring diagram
Fig. 15.

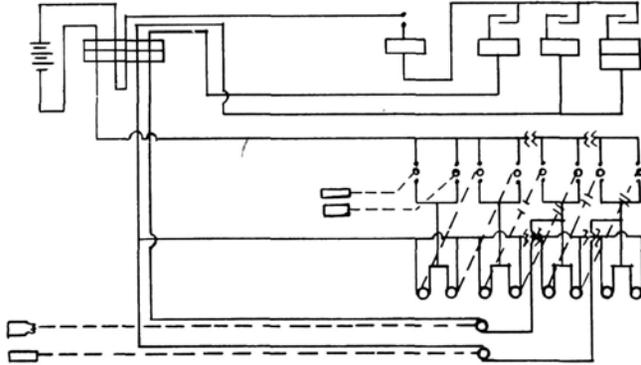
C - Wiring diagram
Fig. 16.

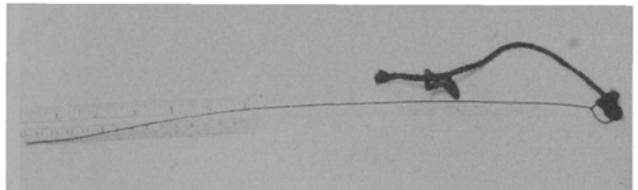
Column 29. Arming wire,
number of. Fig. 17

Note any indication of arming wires whether the wire is still attached or there is only the cord usually attached to it.

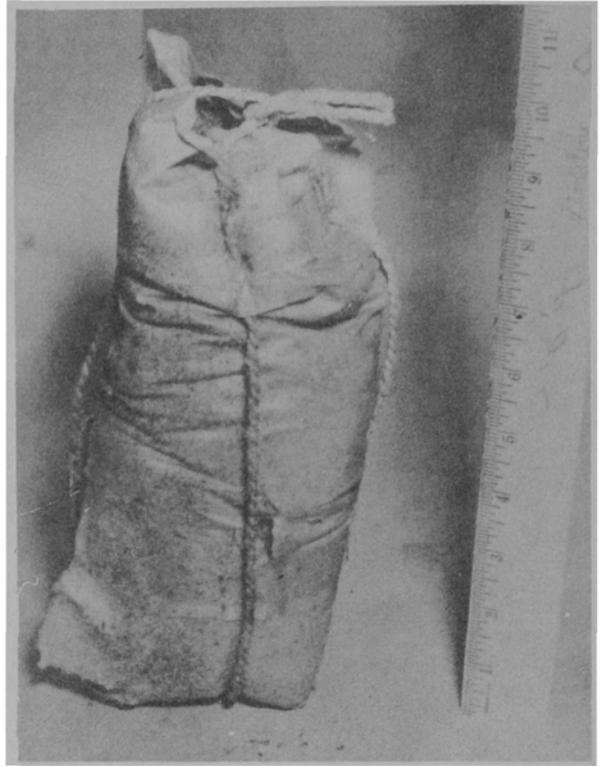
Fig. 18

Column 30. Number of Sandbags
Fig. 18.

Column 31. Weight of sandbags
Fig. 18.

Where more than one sandbag is found note the weight of each sandbag at the bottom of the form, and the number of the plugs to which it was attached.

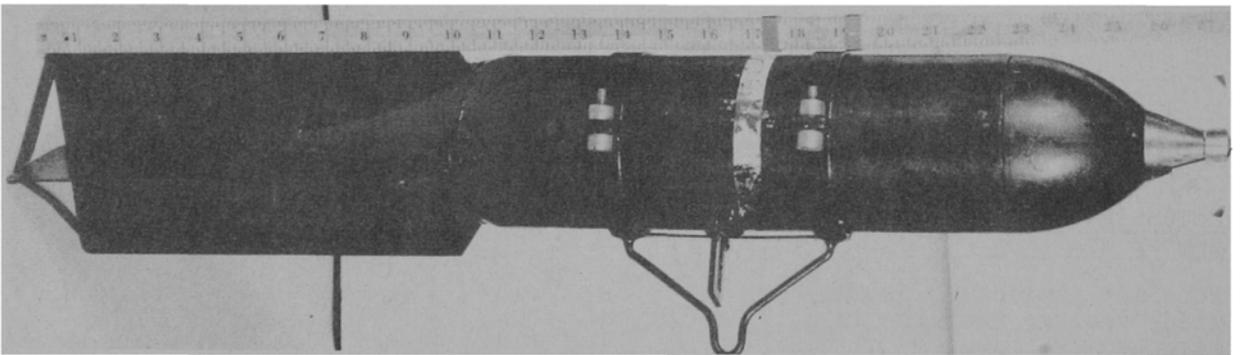
A - 12.8 Kg. Incendiary Fig. 19 and 20

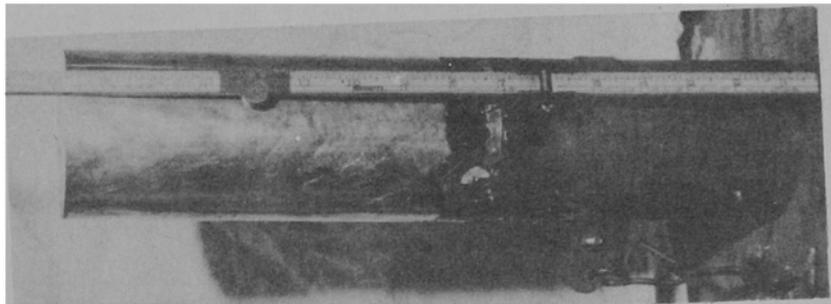
Fig. 21

B - 4.5 kg. (candle type) incendiary bomb.
 15 3/4 inches long and 3 3/4 inches in diameter.

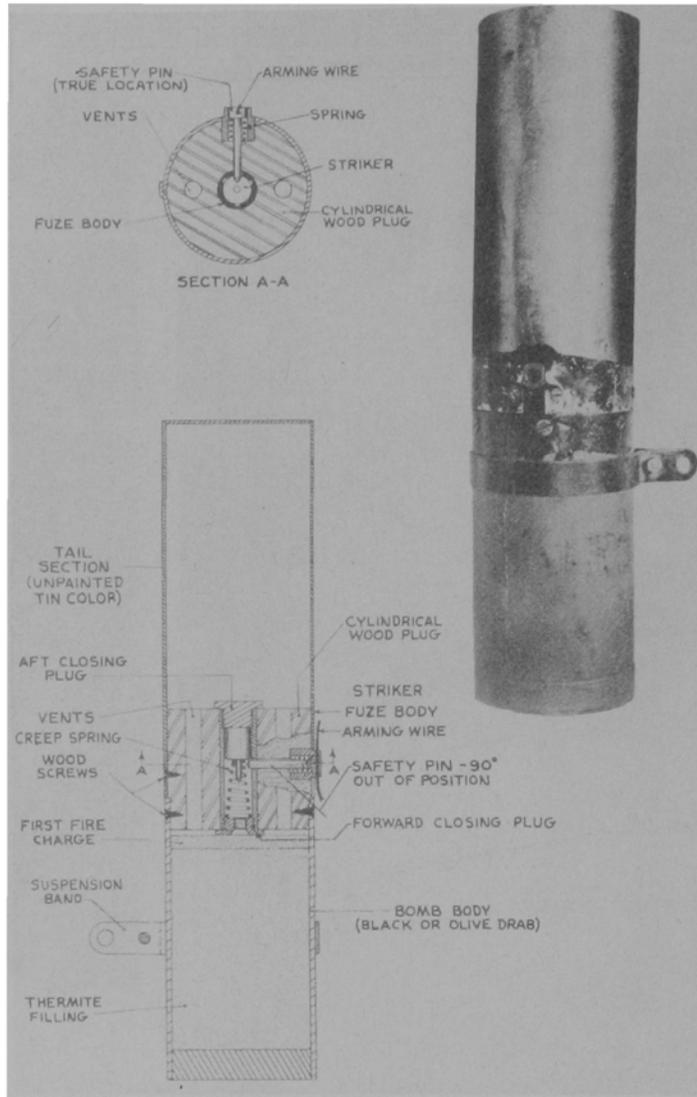
Fig. 22

Column 32. Number of Incendiary Bombs. Fig. 19 and 20 Fig. 21 and 22

Column 33. Type of incendiary bomb. Fig. 19, 20, 21, and 22.

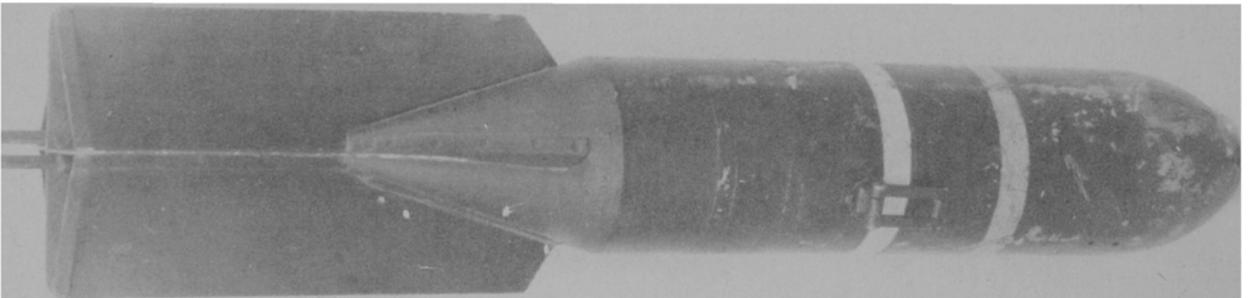
Fig. 23

Column 35. Type high explosive anti-personnel bombs Fig 23.

A - 15 kg. with A-2(b) fuze Type 92 Bomb

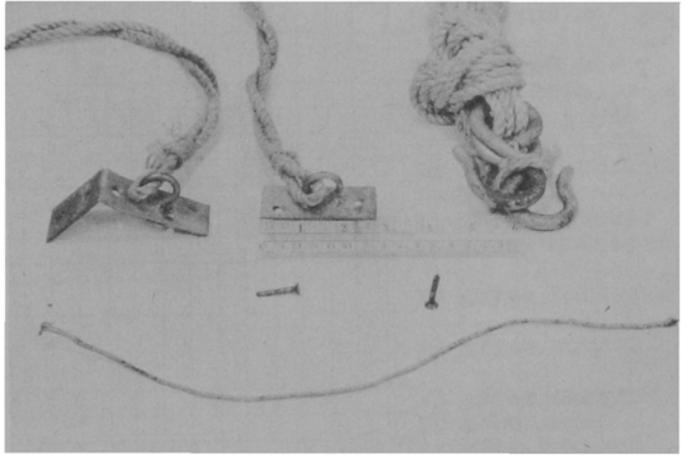
Fig. 22

Miscellaneous pieces found
at Woodsan, Texas
Figs. 22, 23, 24.

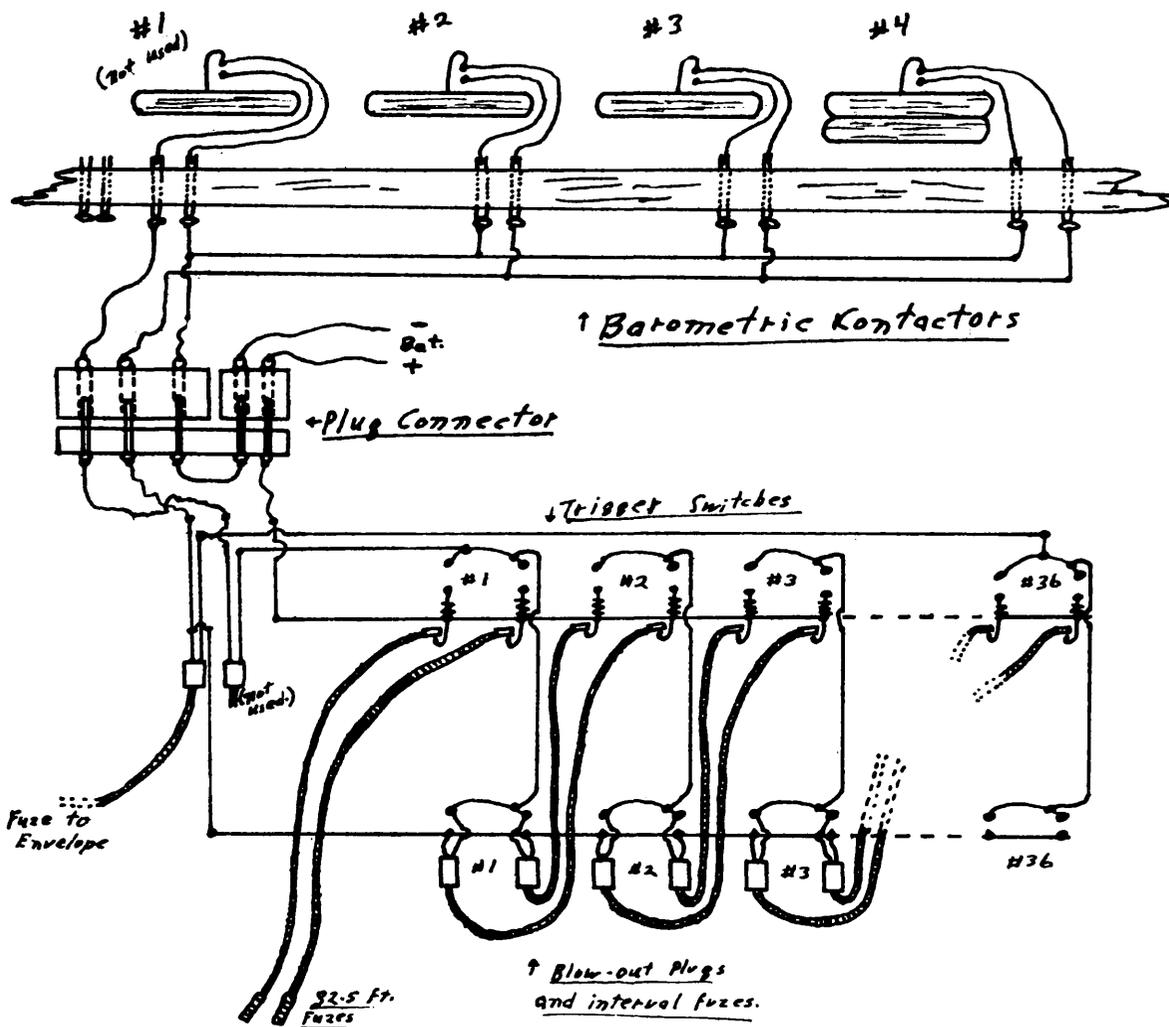
Enclosure F.

Electrical and Fuse Connections in Release Gear

12. The wiring diagram of the ballast release mechanism is the same as that of Encl.(F), Ref.(b), with one exception. This diagram shows a wire leading from one of the central blow-out plugs to the first pair of trigger switches. This should be corrected to show this as a connection between the blow-out plug and the ninth pair of trigger switches. Thus, if the fuze trains fail anytime after the ninth pair of switches is activated, a decrease in altitude by the balloon will activate the detonator in one of the central blow-out plugs resulting in the dropping of the load attached there and (probably) demolition of the balloon.

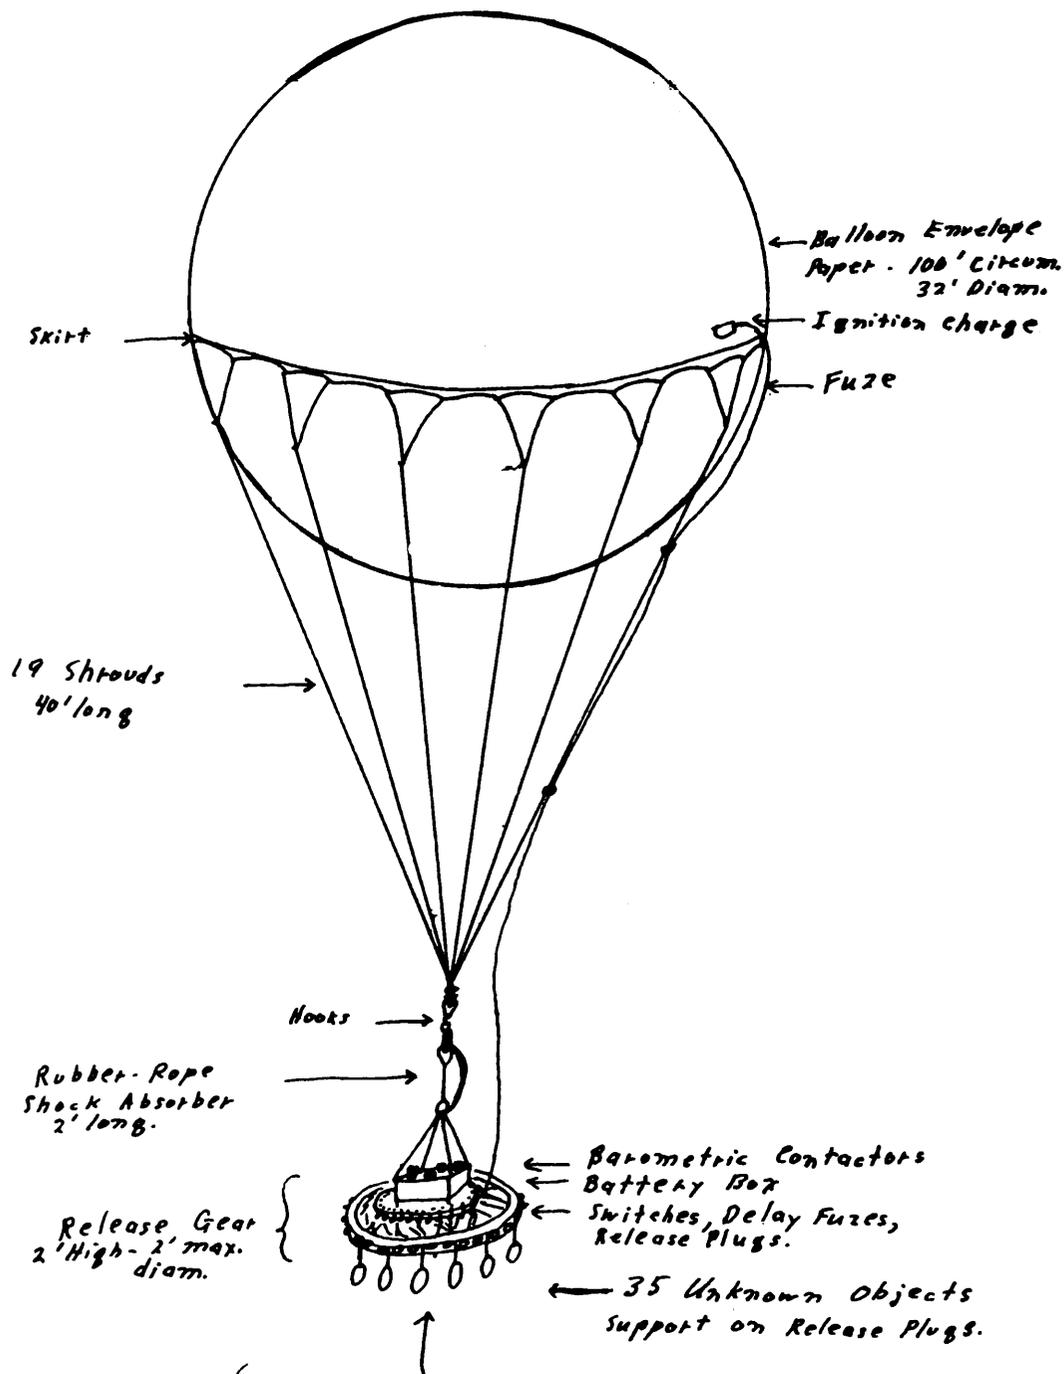
Enclosure G - Standard Japanese Paper Balloon

(May have additional gear attached.)

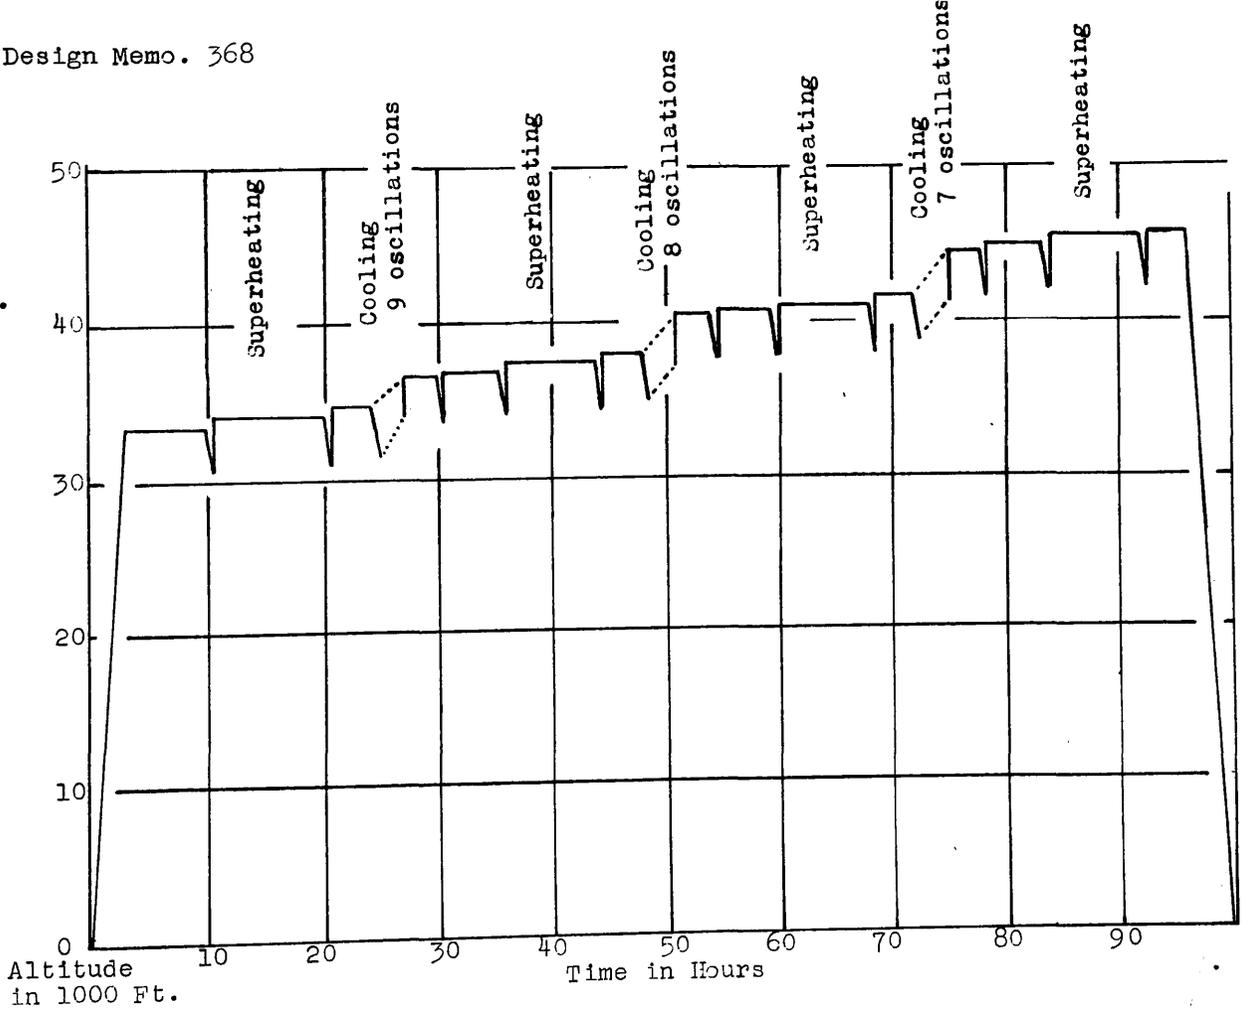
Design Memo. 368

The vertical motion of the balloon is plotted against time in the accompanying figure. One increment of ballast is dropped at each oscillation. After the thirty-fifth oscillation the balloon descends to the ground.

HYPOTHETICAL FLIGHT OF FREE BALLOON WITH GAS VALVE AND AUTOMATIC BALLAST DEVICE
ALTITUDE VS TIME
