# VF-124 and the Cutlass

**Jan van Waarde**

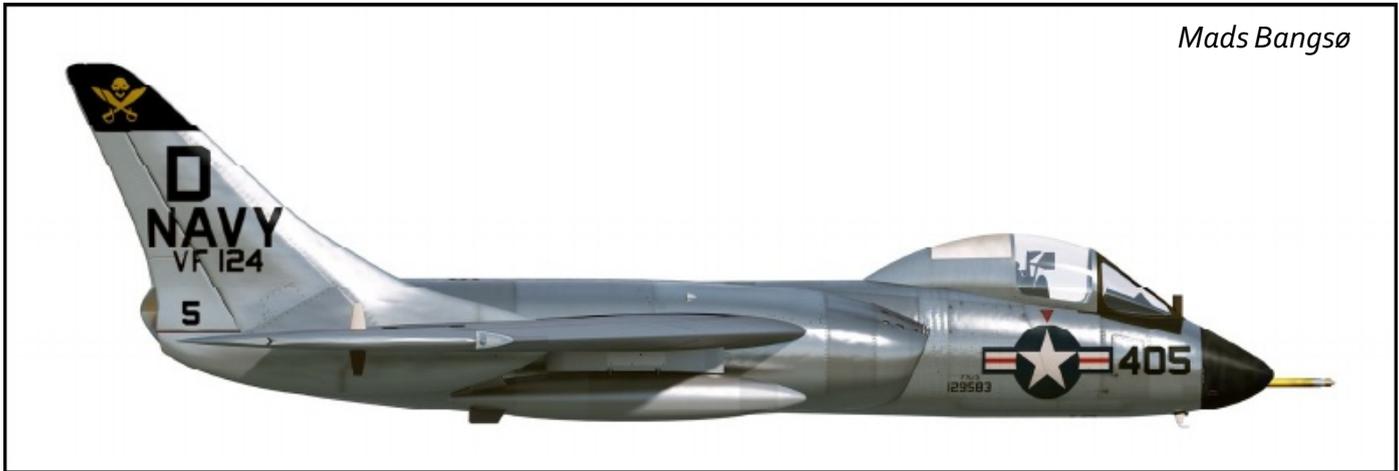
These two F7U/3s of VF/124 are awaiting the start of their deployment on board the USS Hancock. All photographs in this article were obtained by Bill Spidle and Mark Nankivil from the Vought Retirees Club, unless noted otherwise.

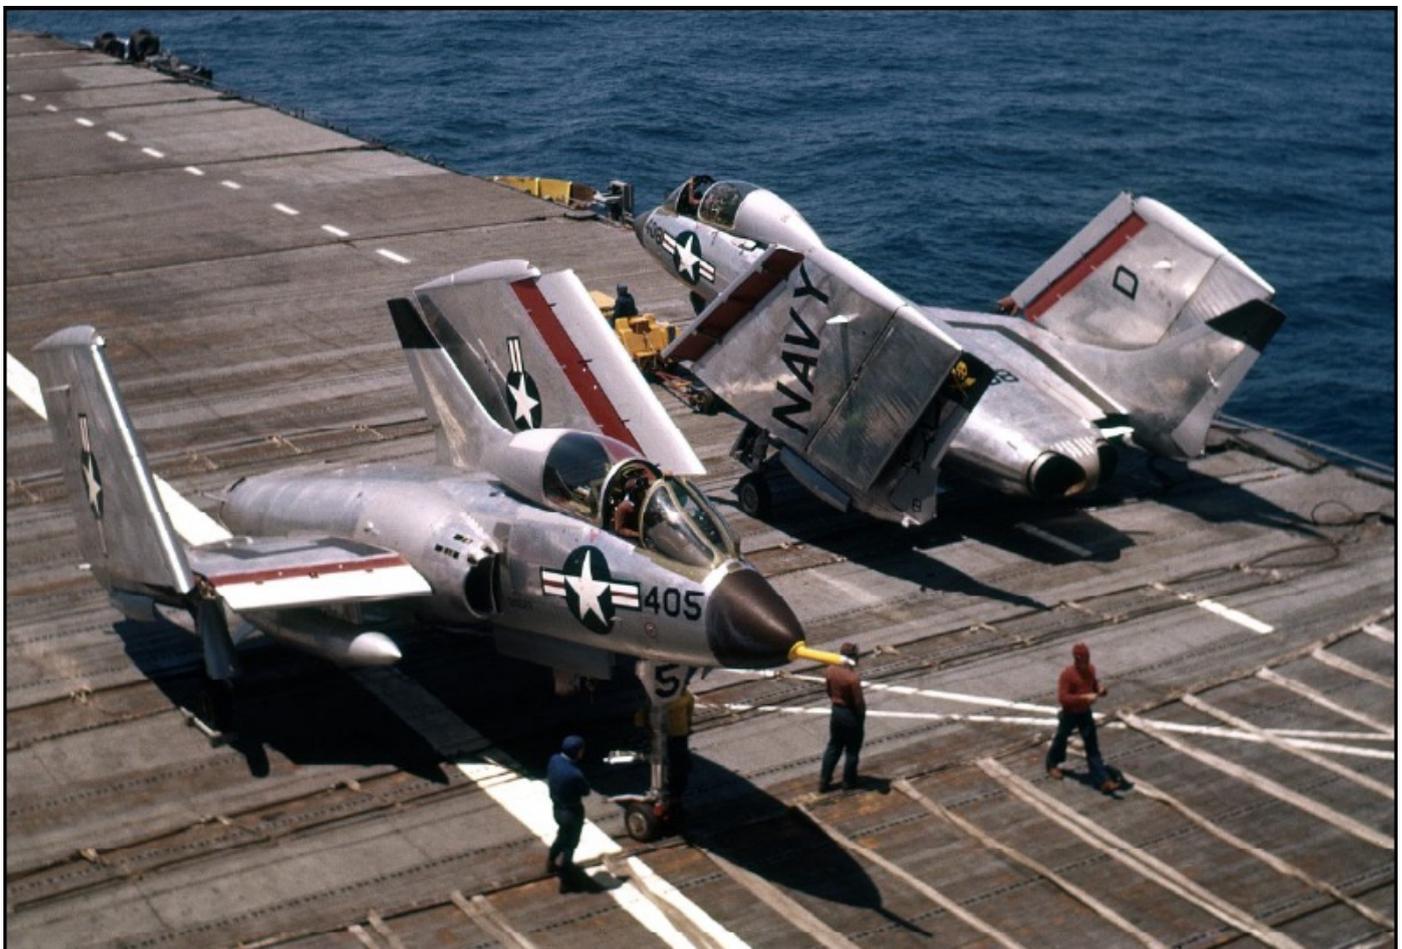
Two F7U-3s being respotted on the deck prior to flight operations at the start of Hancock's cruise. Note the lowered barrier on the carrier's flight deck. At this stage, the aircraft are handled by flight deck personnel, not by the pilots.

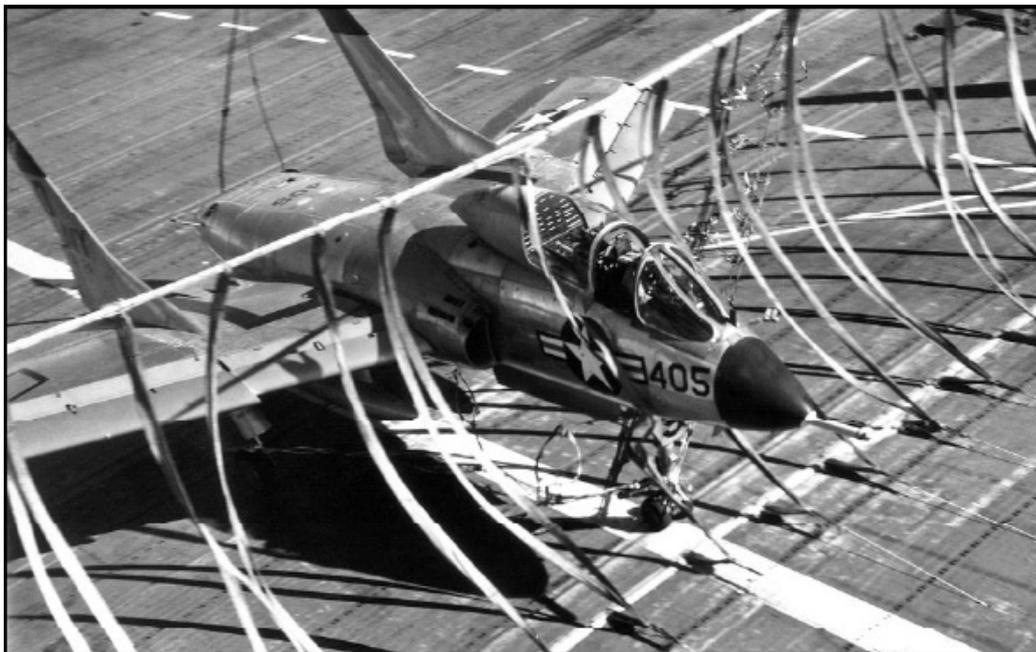
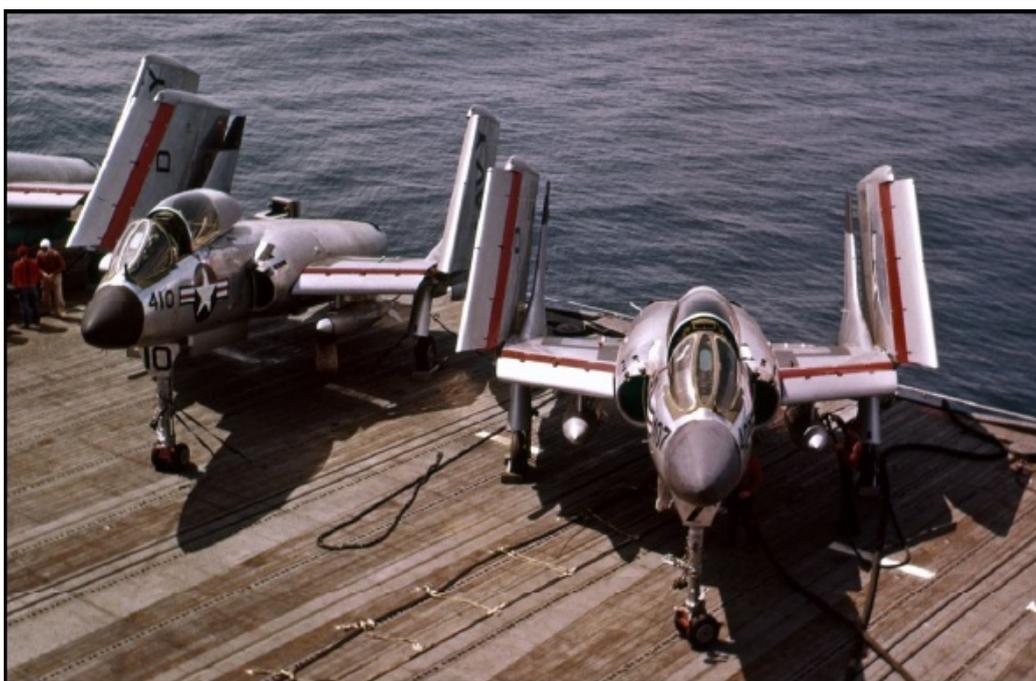
Bottom: a line of F7U-3s along the edge of Hancock's deck. Top: F7U-3 129583 taking the barrier on 19 September, as related in the text. (photo: Glenn Dunham)

the barrier and although it was reported the aircraft suffered slight damage only, it was struck off charge following the incident and never flew again. Remember, these were the times of 'straight' carrier decks and there was no room to bolter (i.e. to go around and try again) once you had committed to a landing; all you could do was take the barrier that prevented you from crashing into the pack of parked aircraft on the bow. It comes as no surprise that one of the main outcomes of this first Cutlass cruise was the realization that the F7U-3 was completely incompatible with the straight (axial) deck concept. Operations of an aircraft like this needed a carrier which would be always able to provide a

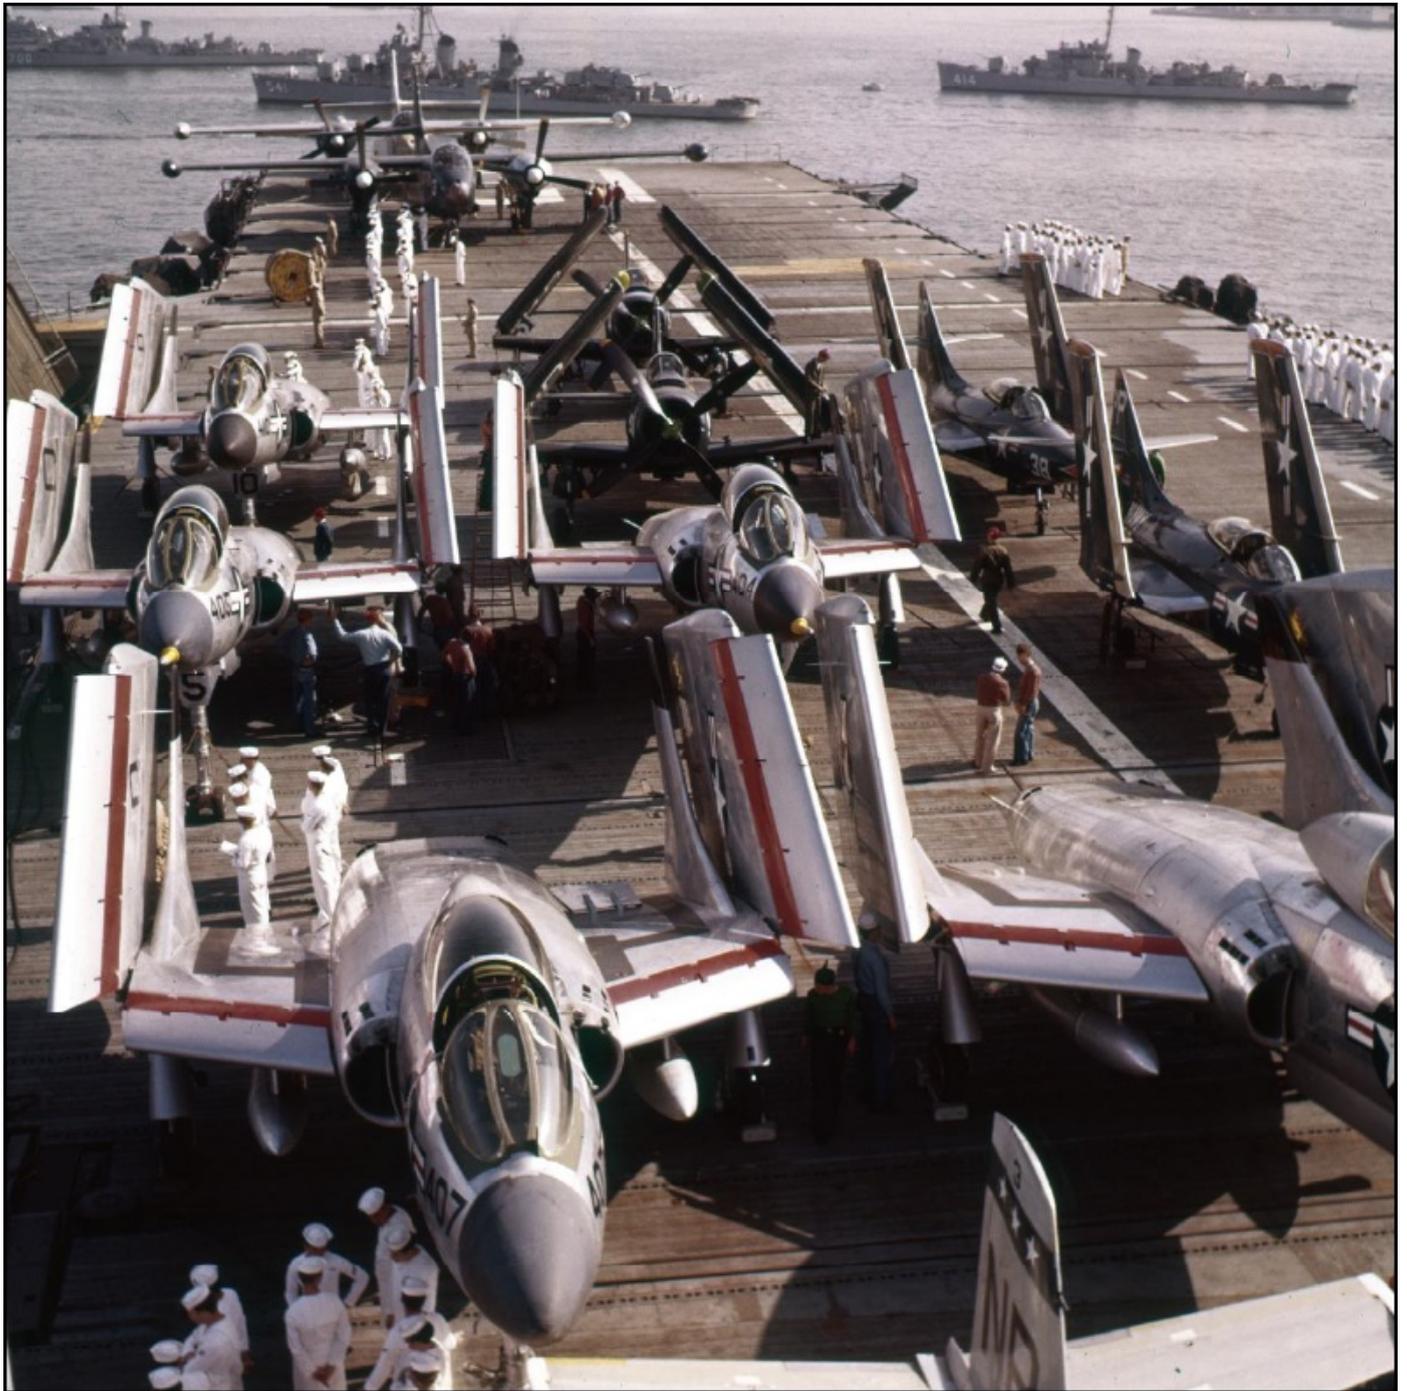
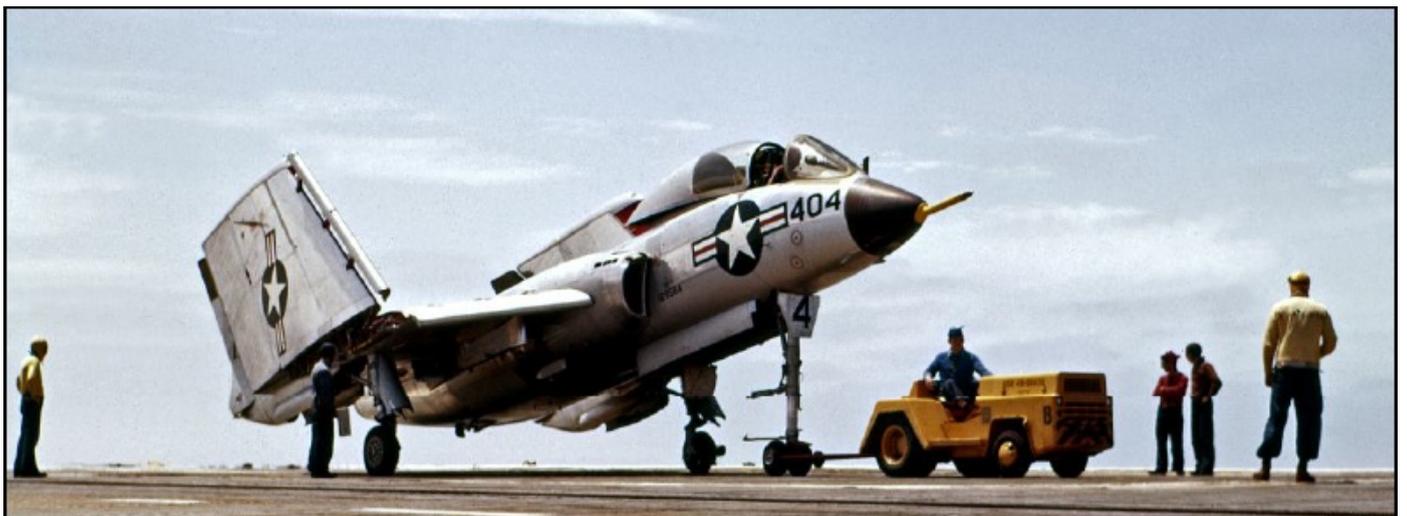
Above: An impressive amount of hardware is parked on Hancock's deck just prior to departure from San Diego,. Apart from VF-124's F7U-3s, AJ-2s, AD-6s of VA-125, F9F-8s of VF-121 and the tail of a VC-3 F2H-3 can be seen. Below: a VF-124 F7U-3 Cutlass is being respocted.

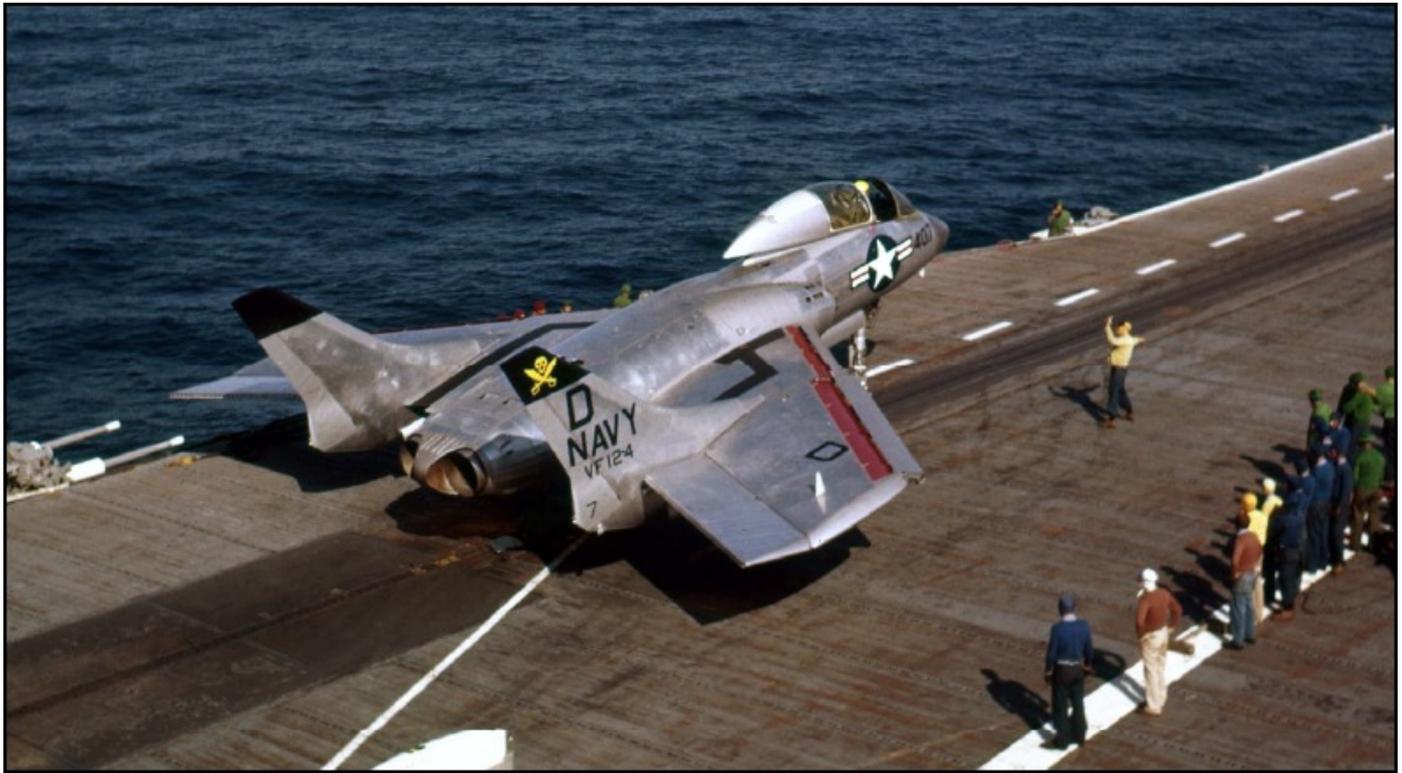
A Cutlass just moments before being launched from the USS Hancock. Note that the deck is still made from wooden planks. This photograph also shows the distinctive markings for VF-124.

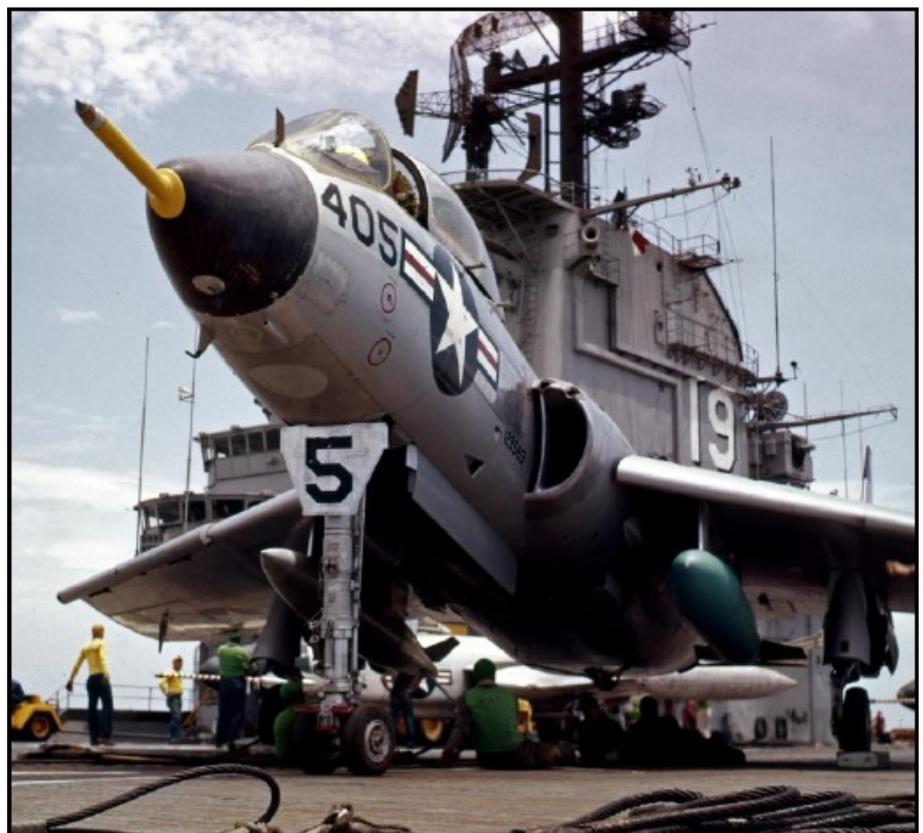
Several of the Cutlasses of VF-124 carried refuelling probes on the nose, like this one.

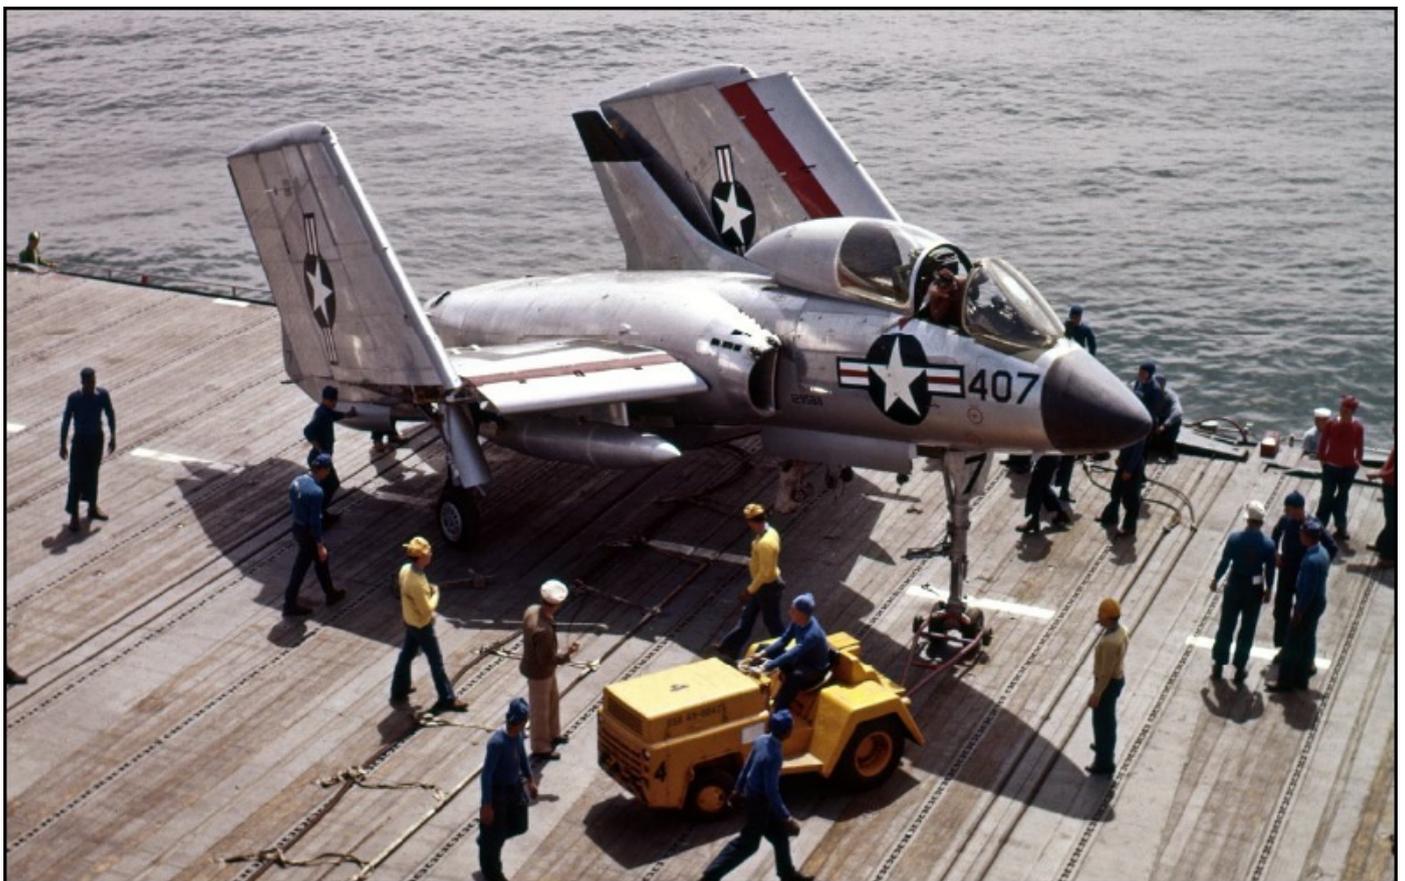
*Another fascinating old-fashioned flight deck scene of a VF-124 Cutlass being respotted on deck. Note that underwing tanks were used to extend range.*

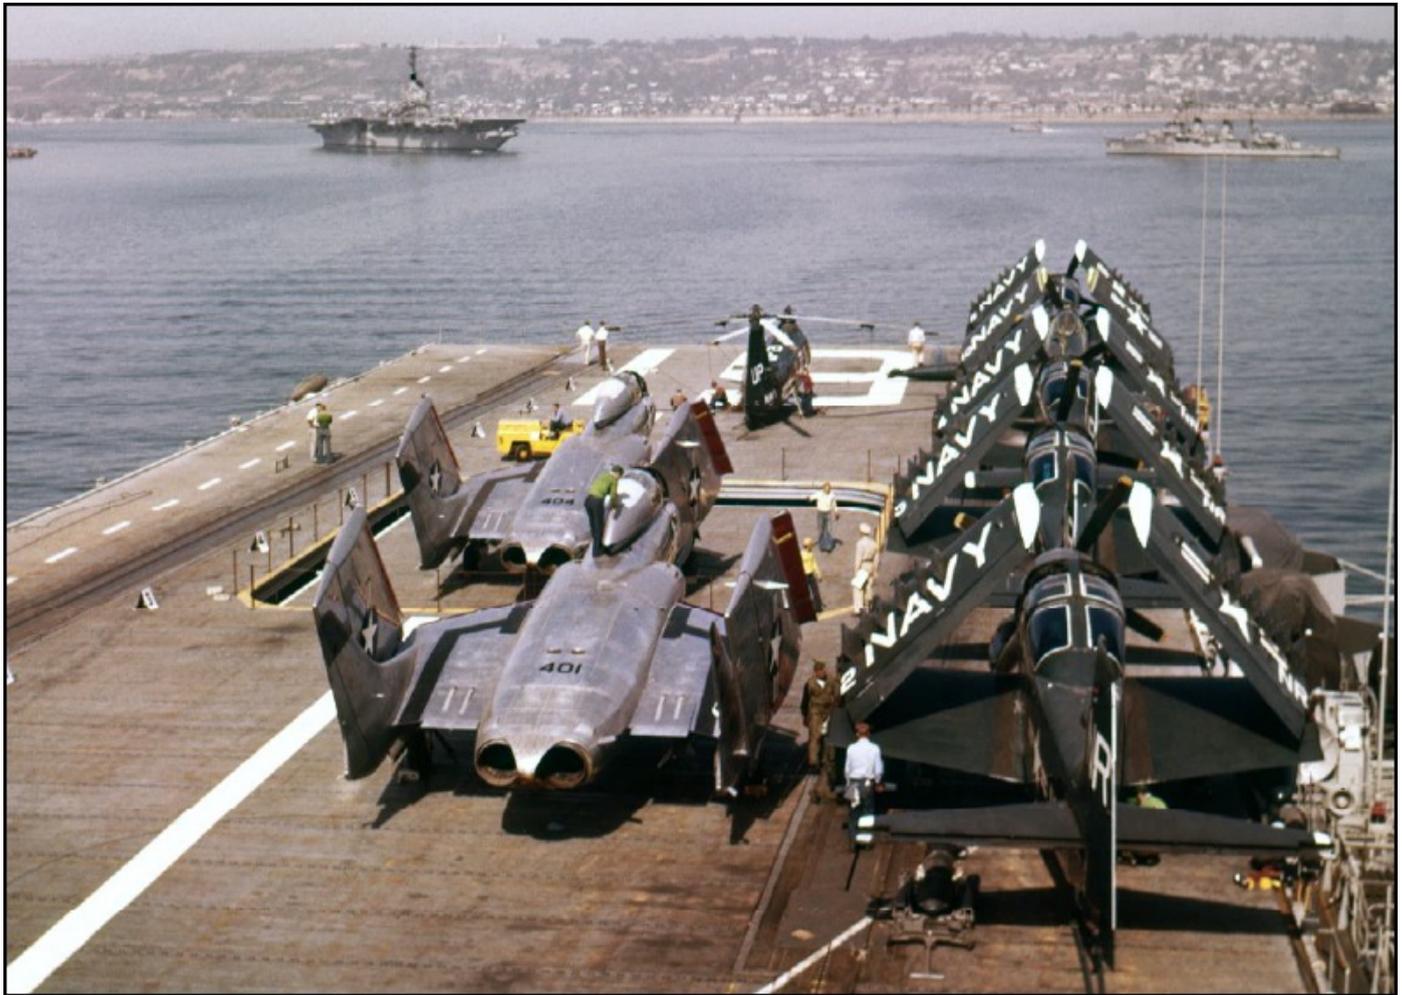
Hancock at anchor in San Diego Bay, prior to the start of the cruise. On the right are the AD-5Ns of VC-35 Det.G.

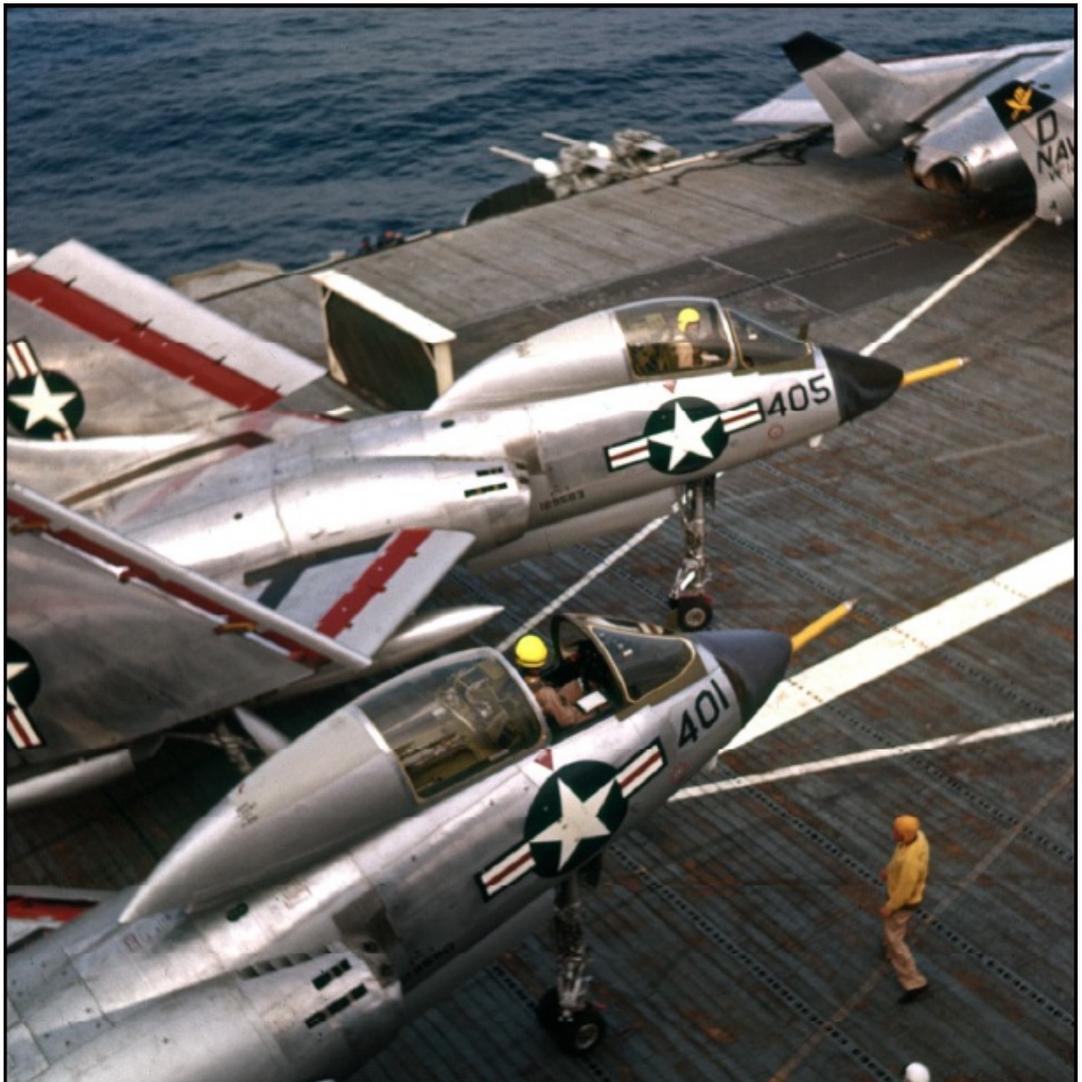
*Cutlass flight operations are in full swing with one aircraft on the catapult and another pair awaiting their turn. Note the primitive blast deflector.*

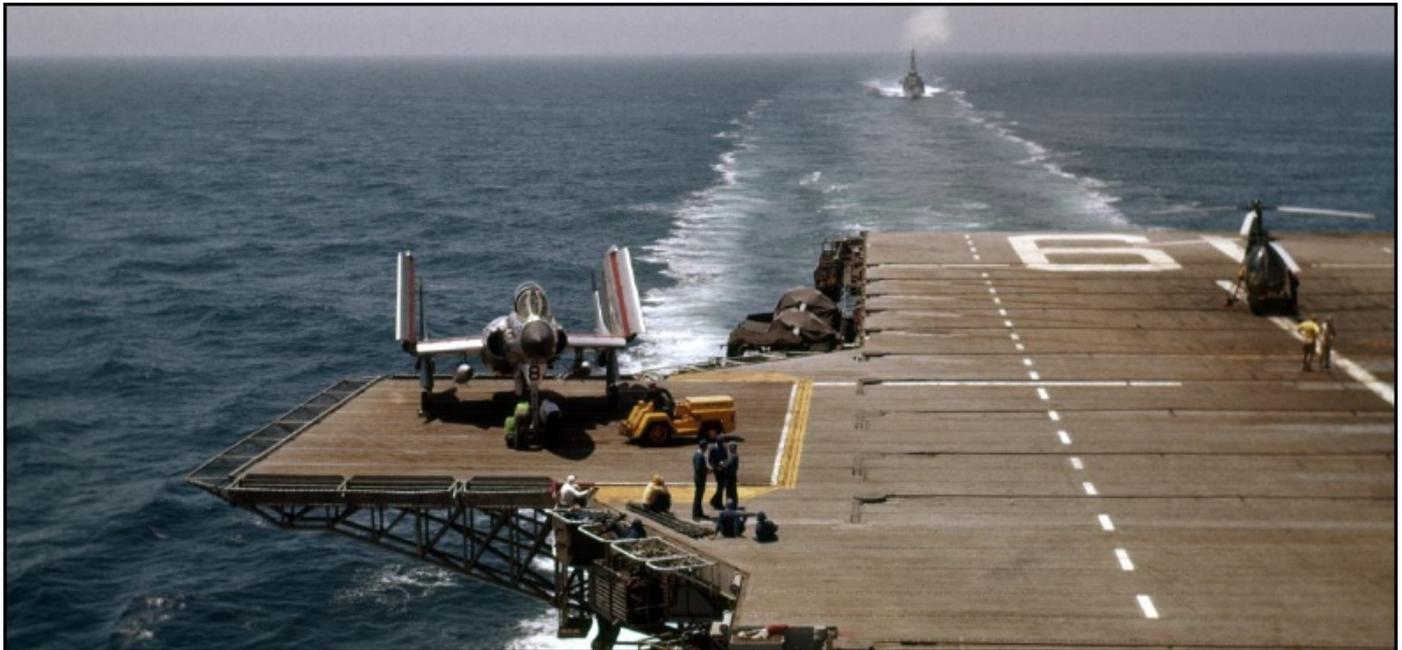
An F7U-3 has just been brought above decks on the USS Hancock. Note the large number of arresting cables on
