QCX
AVRO
ARROW
QTR-
1958-3
copy-2

quarterly technical report

30 Sept. 1958

AVRO AIRCRAFT LIMITED

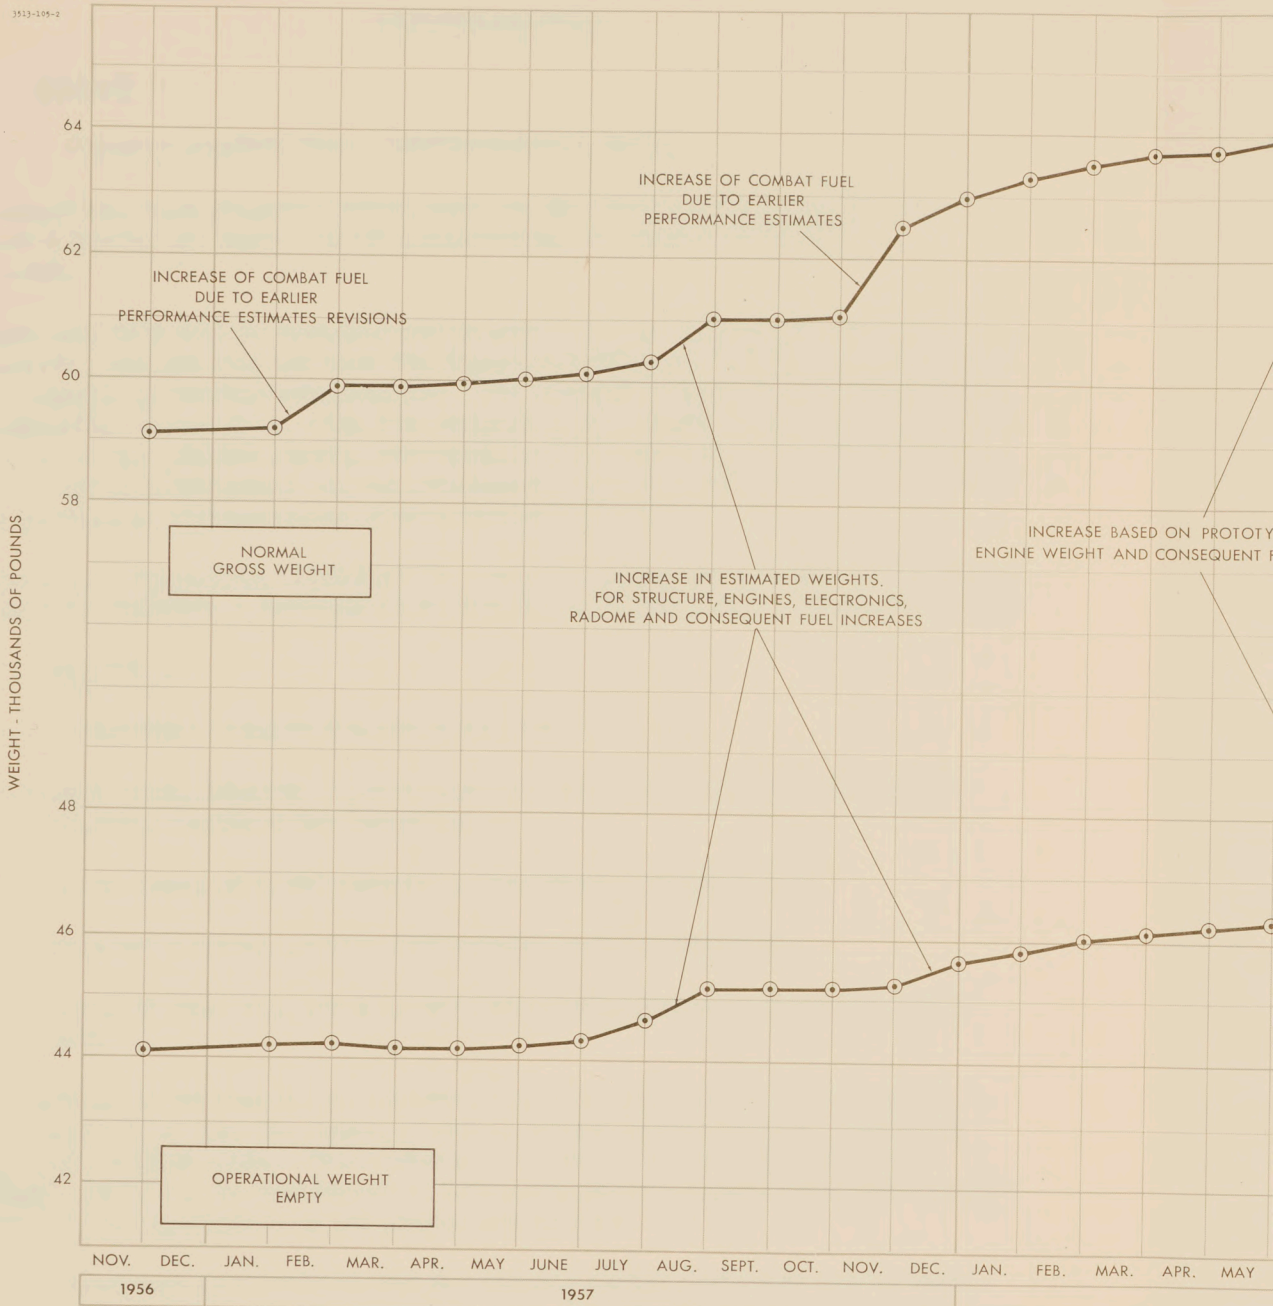
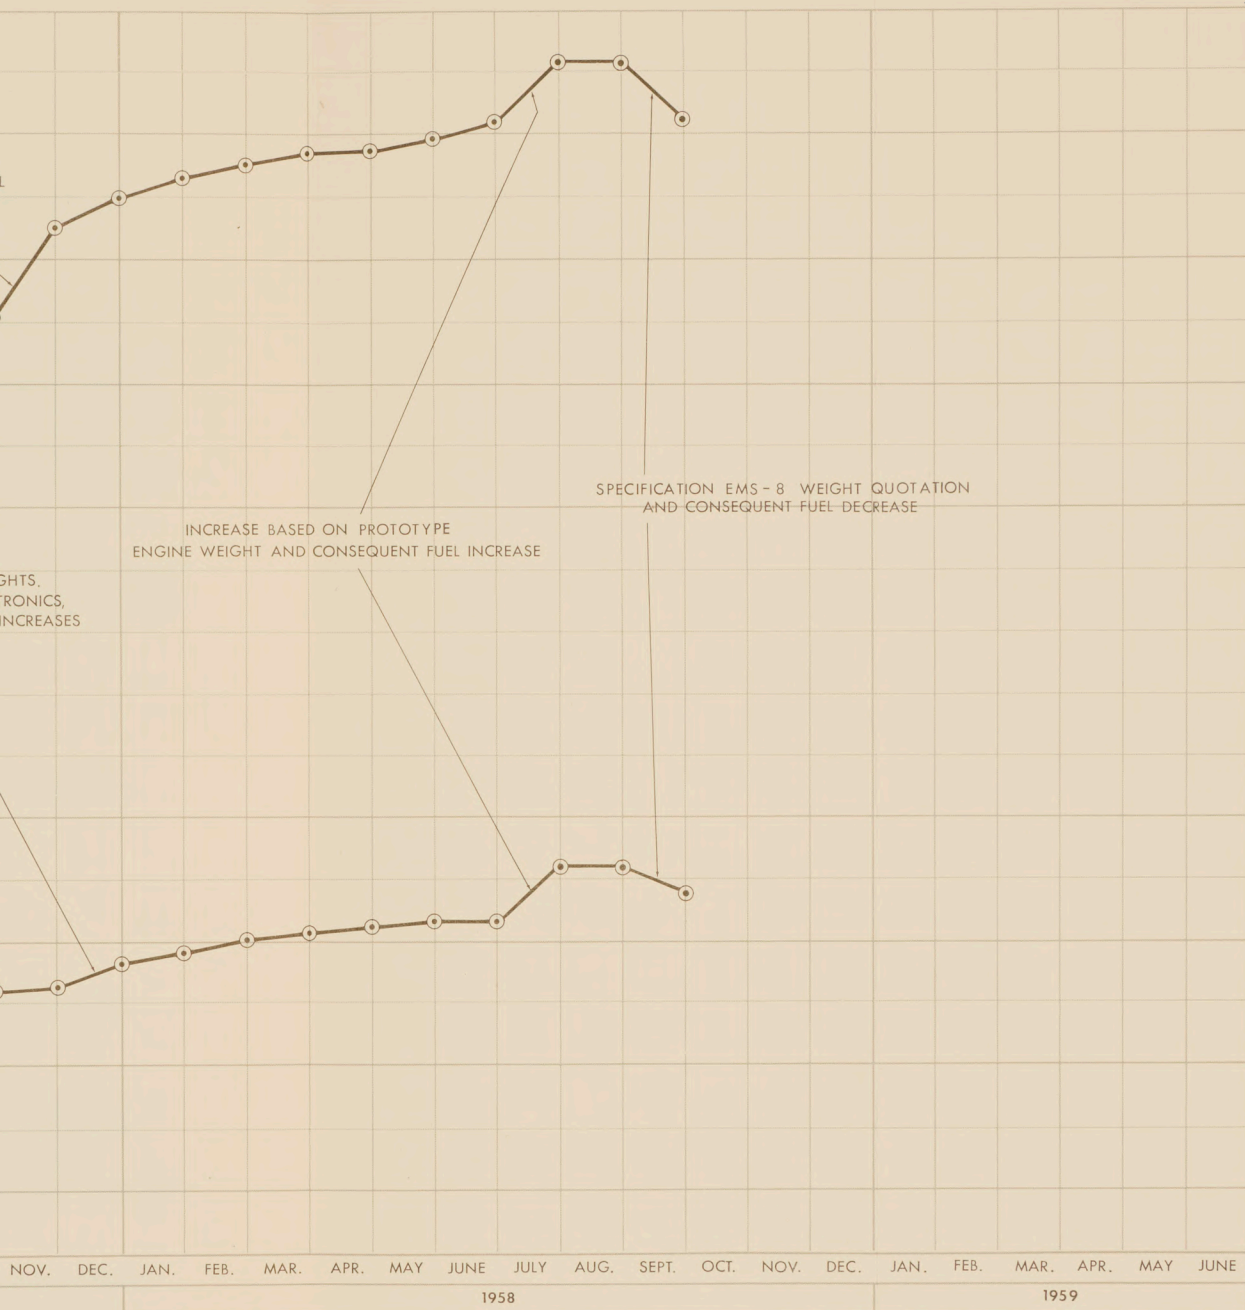
FIG. 3 WEIGHT HISTORY - ARROW 2 - OPERATIONAL

Weight - Pounds			Notes
	Present	Previous	Change	
Structure	19228	19163	+65	(a) +65
Landing Gear	2698	2658	+40	(b) +40
Power plant and services	10771	10814	-43	(a) -69 (c) +26
Flying controls group	1966	1932	+34	(d) +34
Fixed and removable equipment	9082	9094	-12	(a) -12
Trapped fuel	214	-	+214	(e) +214
Basic Weight	43959	43661	+298	-
Useful load (less fuel)	2687	2799	-112	(a) -5 (e) -214 (f) +84 (g) +23
Operational weight empty	46646	46460	+186	-
Normal combat mission fuel	17684	17605	+79	(h) +79
Normal combat weight	64330	64065	+265	-

- NOTE:
- (a) Weight accounting.
 - (b) Redesign of main landing gear wheels and legs to meet strength requirements. (Interim only).
 - (c) Fuel system modifications to reclaim residual fuel.
 - (d) Change to higher strength tubing in flying control hydraulic system.
 - (e) Accounting change - trapped fuel now included in aircraft basic weight in accordance with chapter 30 of RCAF Spec. CAP 479.
 - (f) Addition of missile cocoons.
 - (g) Accounting change to include oil in constant speed drive separate oil system.
 - (h) Fuel weight change due to change in operational weight empty.

It should be noted that the operational weight empty used in this report is 557 pounds less than the figure quoted in weight report number 7-0400-34 Issue 22, August 1958. This difference is due to an increase in engine weight, which is not considered in this performance report since the revised weight is not applicable to the production engine.

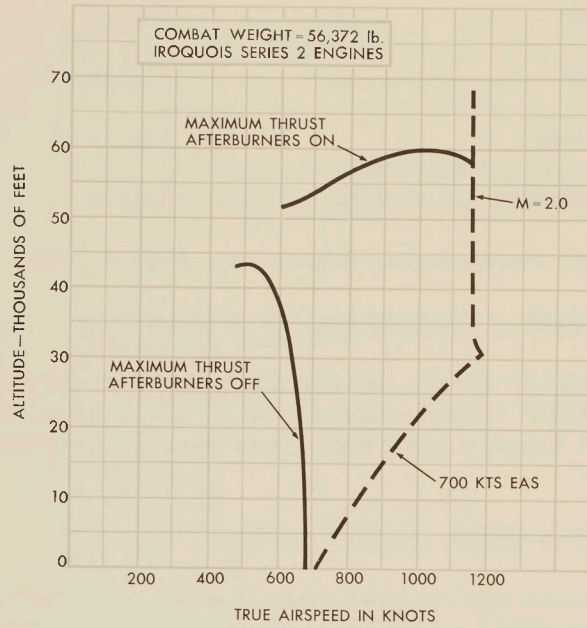
FIG. 4 ARROW 2 - MAXIMUM LEVEL SPEED

Performance estimates are based on ICAO standard atmosphere conditions, clean aircraft (i. e. no ventral tank) and CG at 29.5% MAC.

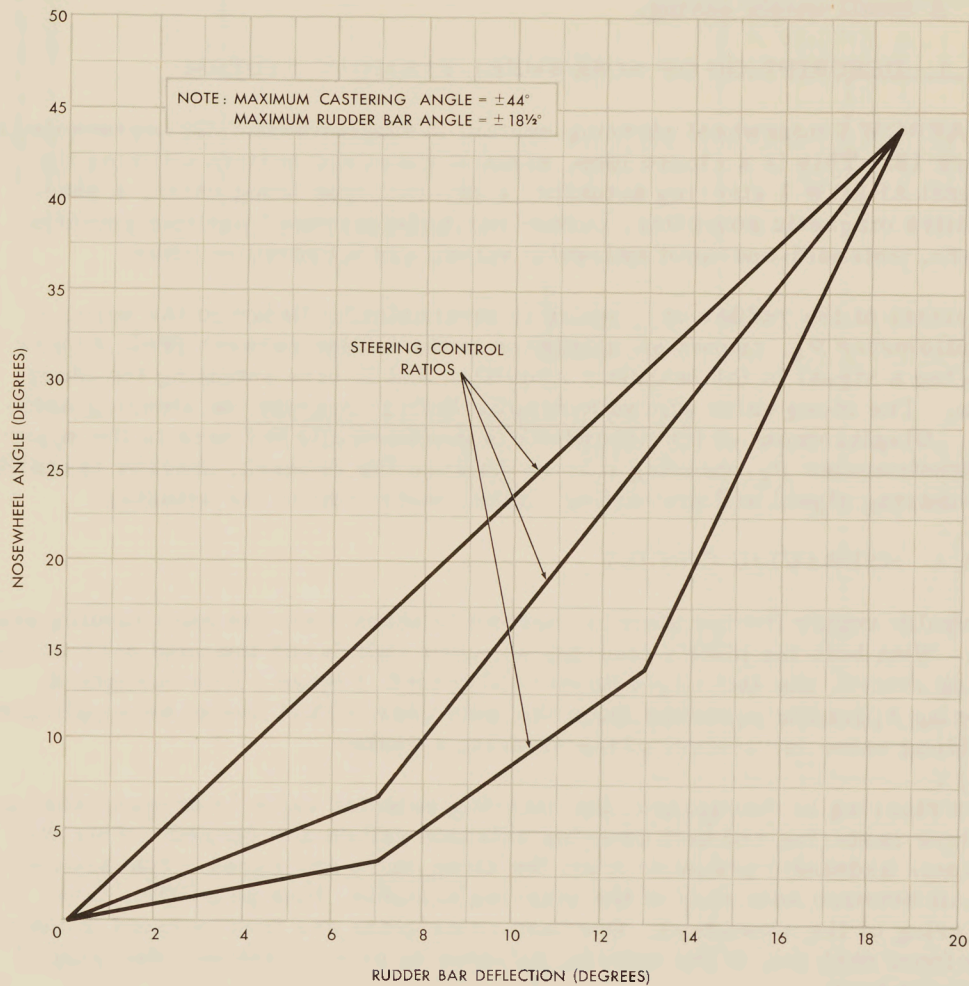
FIG. 17 NOSEWHEEL STEERING CONTROL CHARACTERISTICS (TRIAL INSTALLATION)

Preliminary design of an electro-hydraulic nosewheel steering system, to replace the original mechanically-operated arrangement, has now been completed. Trial installation and flight testing will be conducted on aircraft 25202 in order to develop an operational system for ARROW 2.

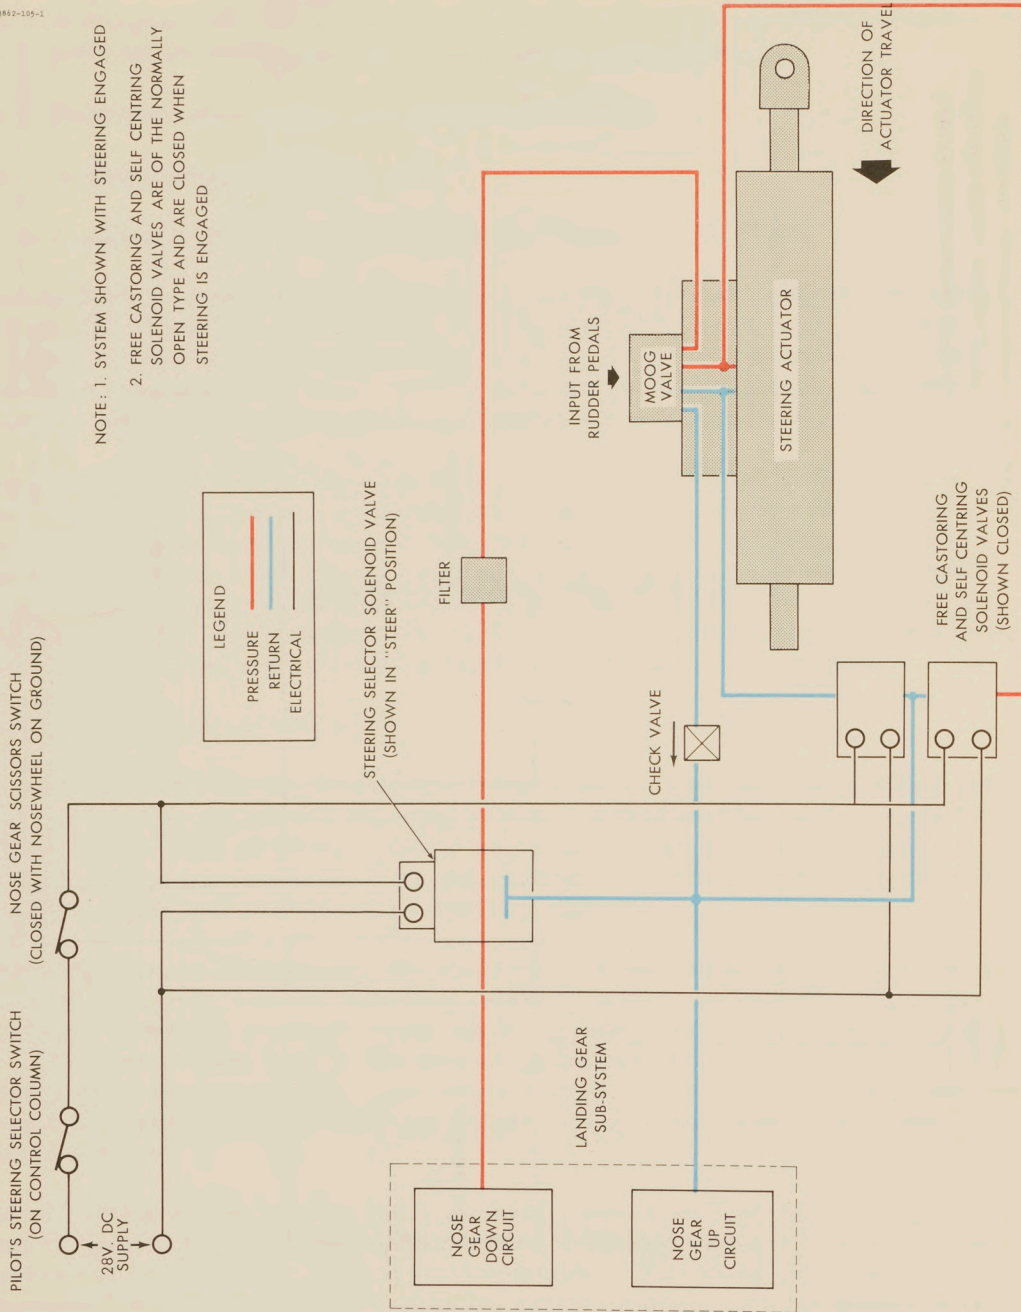
FIG. 19 HYDRAULIC SCHEMATIC - NOSEWHEEL STEERING SYSTEM

NOTE: 1. SYSTEM SHOWN WITH STEERING ENGAGED
 2. FREE CASTORING AND SELF CENTRING SOLENOID VALVES ARE OF THE NORMALLY OPEN TYPE AND ARE CLOSED WHEN STEERING IS ENGAGED

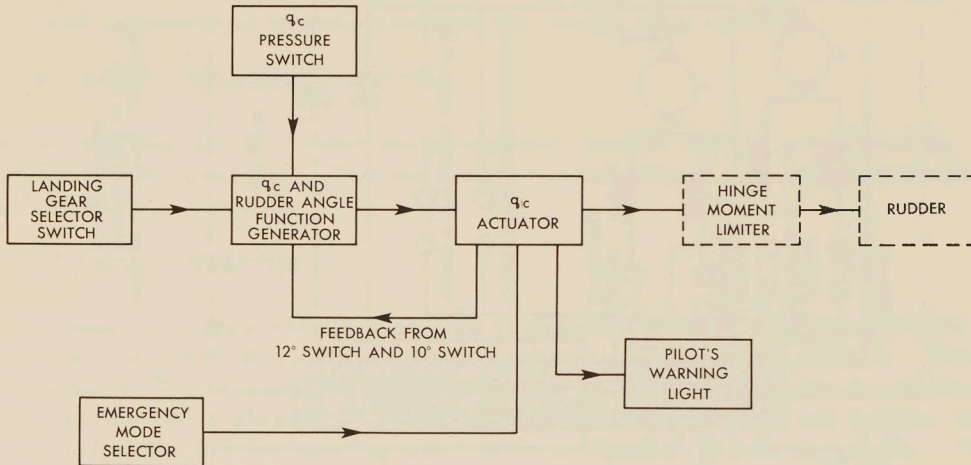
FIG. 20 Qc ACTUATOR SYSTEM - BLOCK DIAGRAM

A warning light is included in the system to indicate improper positioning of the q_C actuator at any flight condition. Should the system fail at high q_C position, the emergency system may be selected.
